**FIRST CHOICE**  
Inspections

# Property Inspection Report

17763 ABC Court  
San Diego, CA 92131

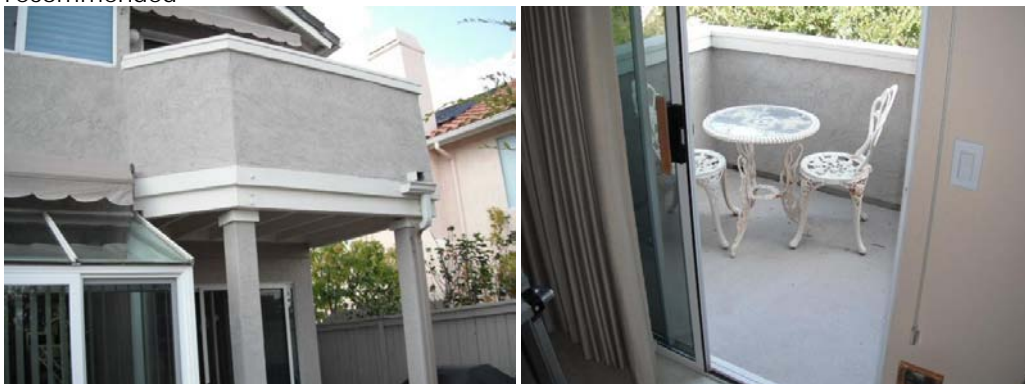
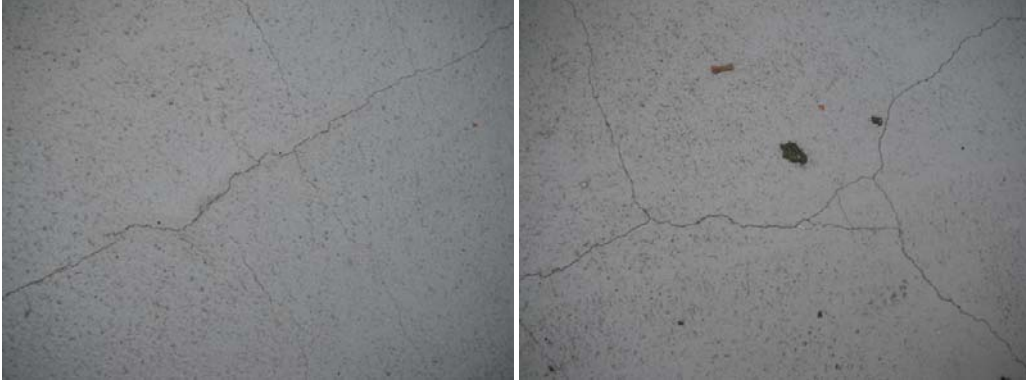
- ☒ ☐ ☐ ☐ Walks: Concrete
- ☒ ☐ ☐ ☐ Patio: Concrete
- ☐ ☐ ☒ ☐ Balcony: Polymer coated The waterproof membrane at the balcony decking is cracked open- Prone to water penetration, Evaluation and repairs by a qualified licensed deck/balcony specialist are recommended

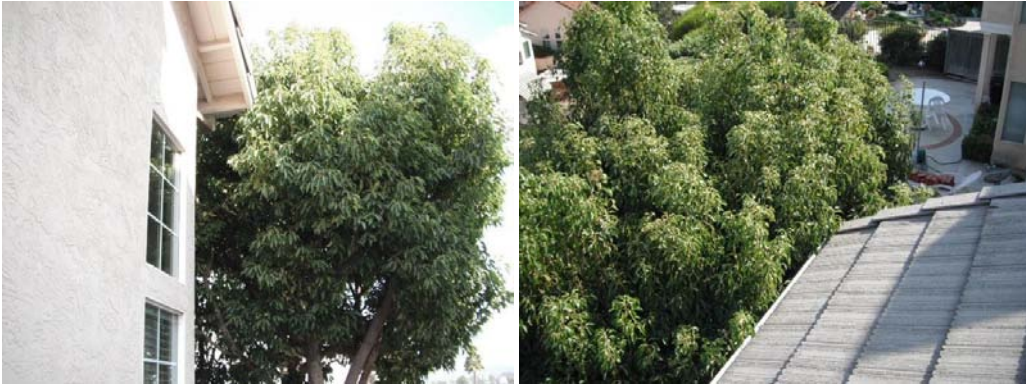
5. ☐ ☐ ☒ ☐ Vegetation: The tree limbs hang over the rear corner of the roof- Pruning by a qualified licensed arborist is recommended to prevent damage to the roofing material, and to prevent insect and rodent access into the house

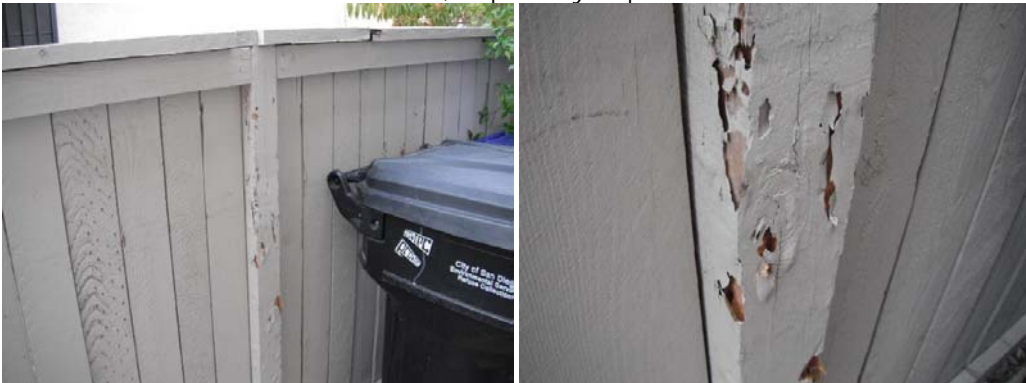
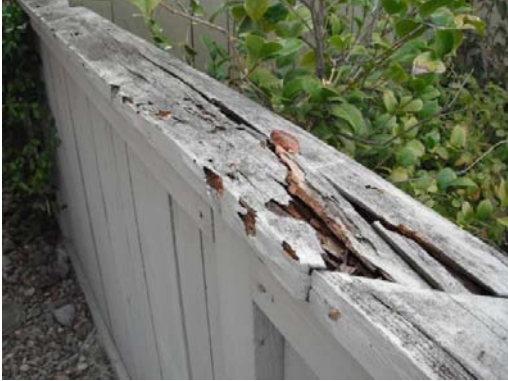
10. ☐ ☐ ☒ ☐ Fences: Wood, Metal There is dry rot and wood-destroying pest damage in the components of the wood fence at the left side of the lot, Repairs by a qualified licensed contractor are recommended

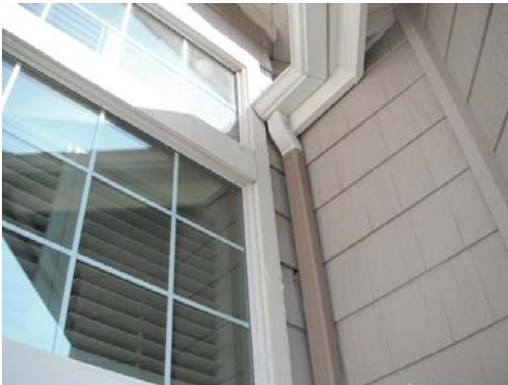
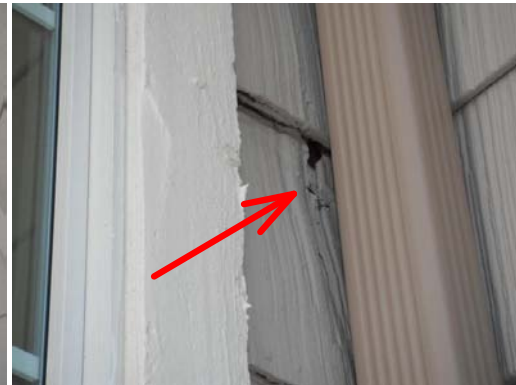
1. ☐ ☐ ☒ ☐ Type: Stucco, Wood shingles There is moisture damage and dry rot in the wood shingles behind the gutter downspout by the front entry- Refer to the termite report, Repairs by a qualified licensed contractor are recommended

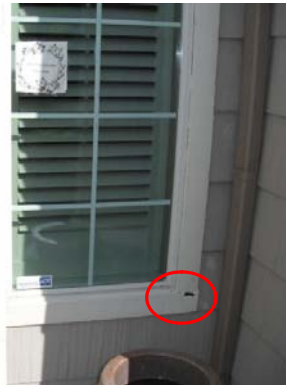
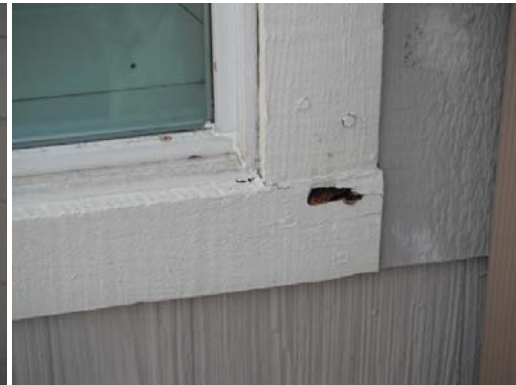
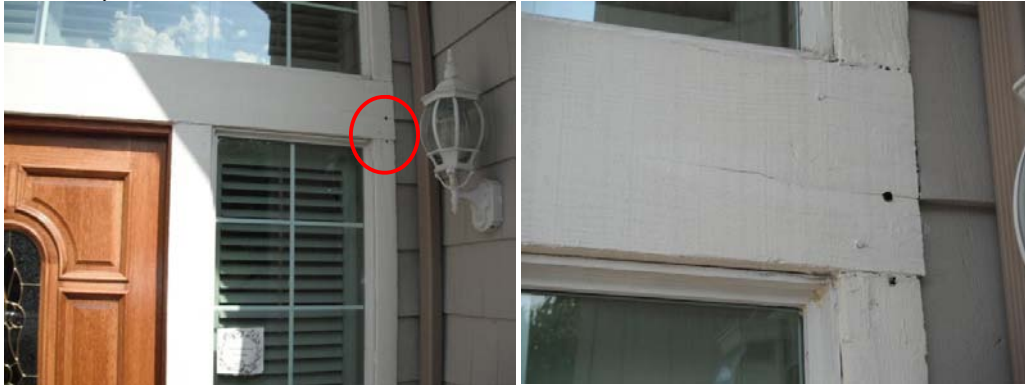
2. ☐ ☐ ☒ ☐ Trim: Wood There is dry rot in the window trim at the front entry, Refer to the termite report, Repairs by a qualified licensed contractor are recommended

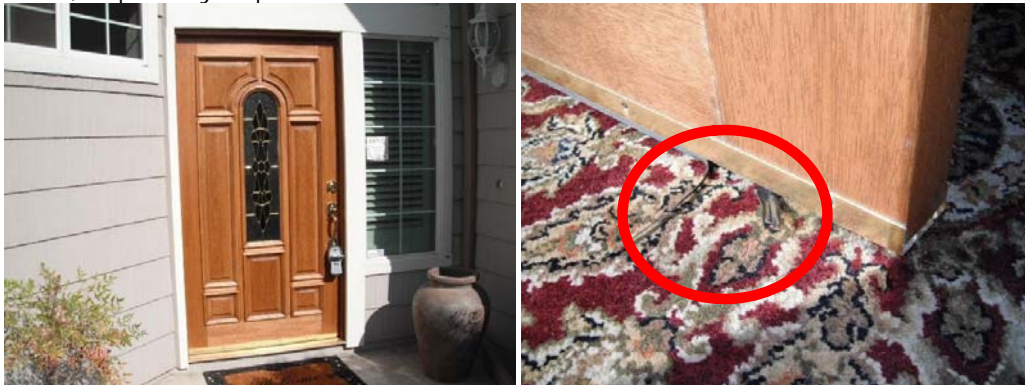
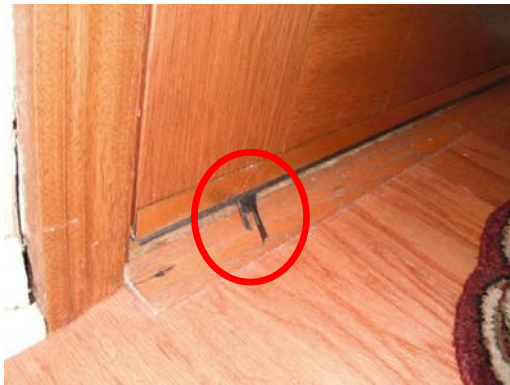
- 3. ☒ ☐ ☐ ☐ Fascia: Wood Refer to the termite report
- 4. ☒ ☐ ☐ ☐ Soffits: Wood Refer to the termite report
- 5. ☒ ☐ ☐ ☐ Door Bell:
- 6. ☐ ☐ ☒ ☐ Entry Door: Wood The weather seal at the bottom of the front entry door is torn- Water intrusion may occur, Repairs by a qualified licensed contractor are recommended

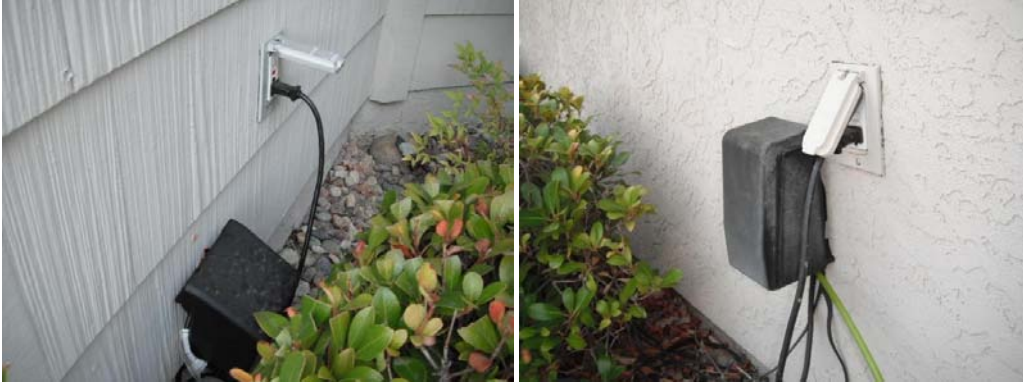
12. ☐☐☐☒ Exterior Electric Outlets: An "in-use" cover is not installed on the exterior electrical outlets used by the timer boxes- Prone to water intrusion- Fire/Shock hazard, Repairs by a qualified licensed electrician are recommended

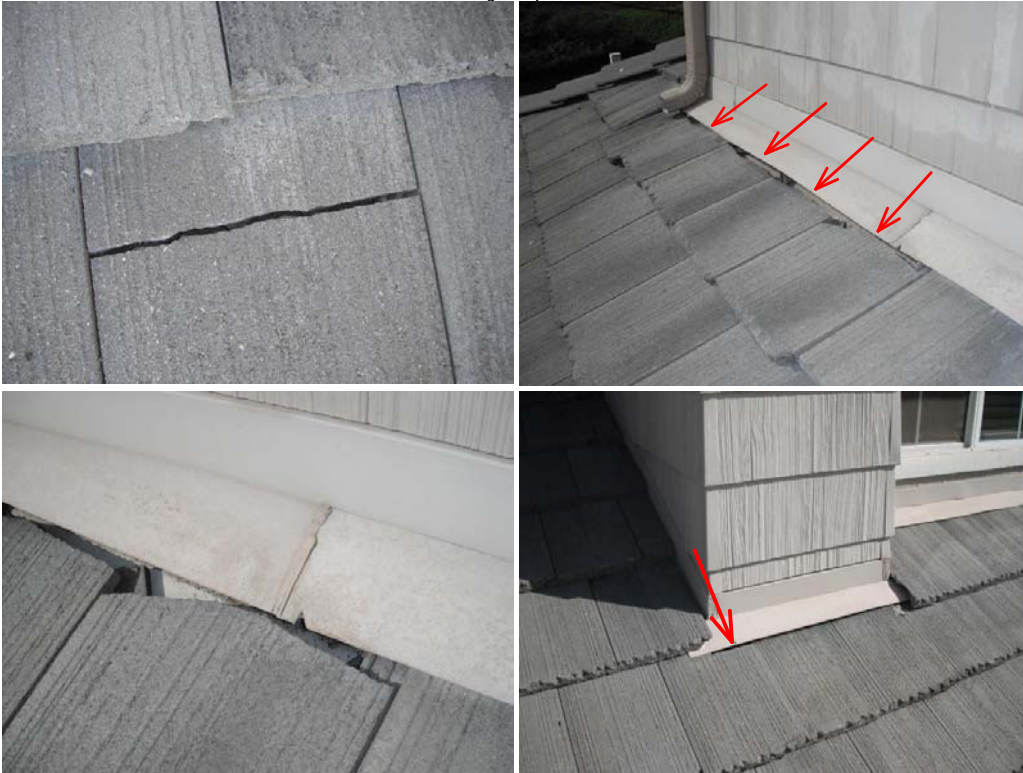
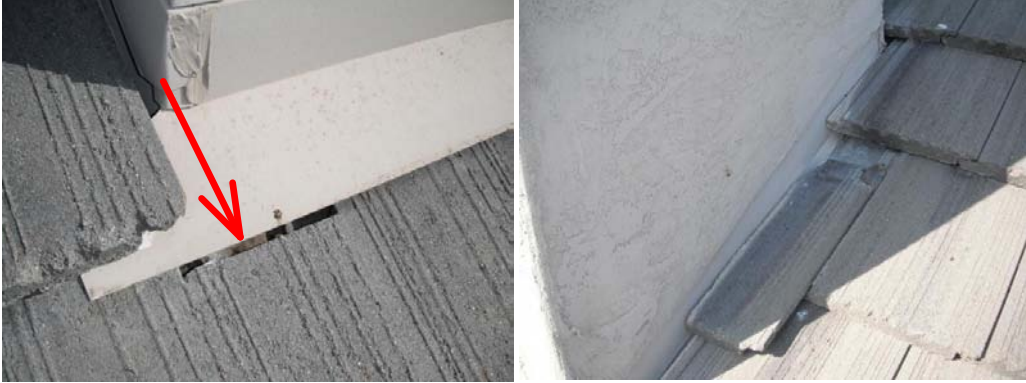
1. Method of Inspection: On the roof
2. ☐☐☒☐ Material: Concrete tile There are several broken and/or loose tiles on the roof at various locations- Water intrusion and roof leakage may occur, A qualified licensed roofing contractor is recommended to evaluate the roof and make all necessary repairs

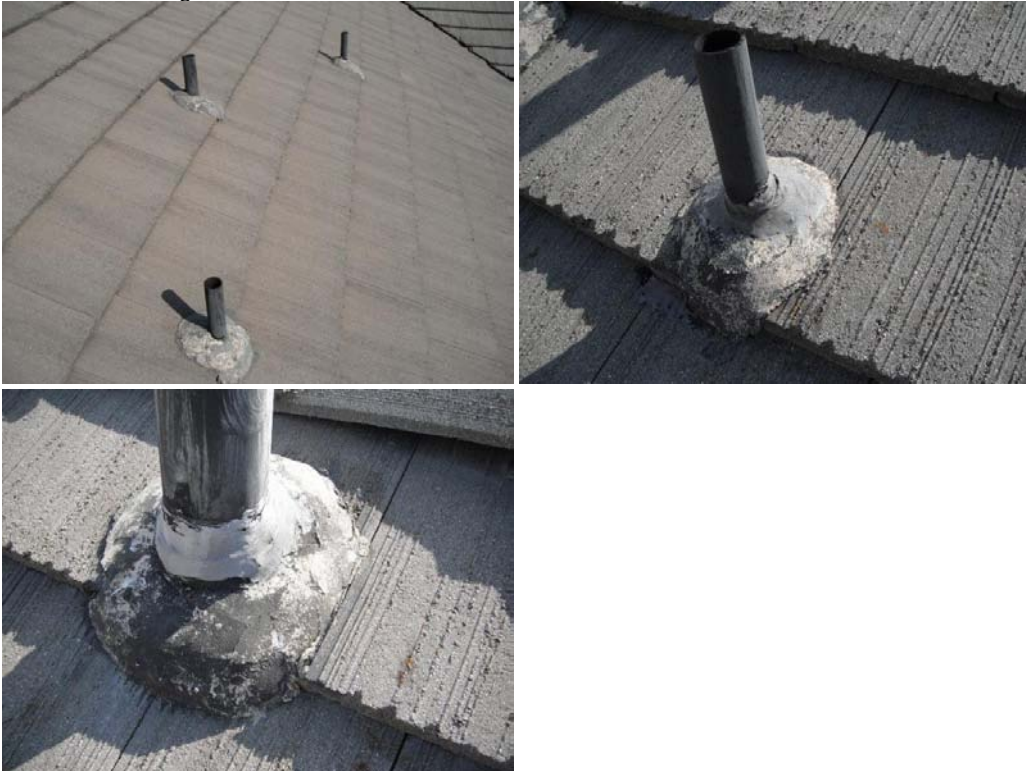
4. ☐ ☐ ☒ ☐ Flashing: Lack of metal flashing was noted at the roof penetrations (mortar used- prone to crack and leak)- Substandard installation- Prone to water penetration, Upgrades to metal flashing by a qualified licensed roofing contractor are recommended

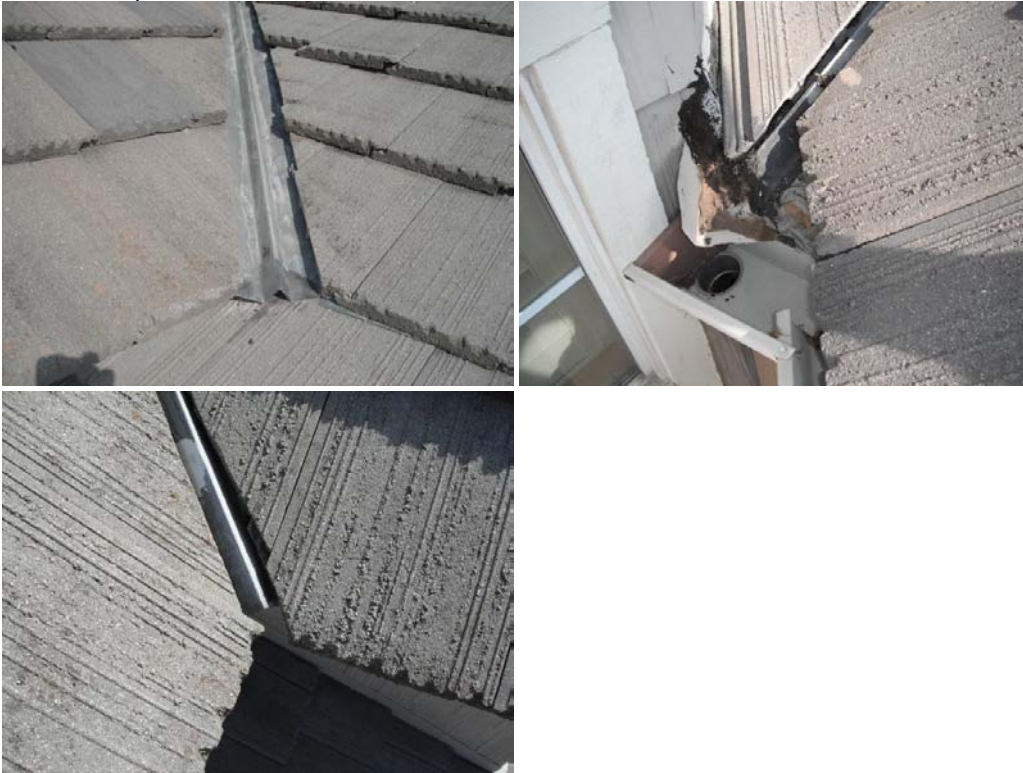
5. ☐ ☐ ☒ ☐ Valleys: Pre-formed galvanized metal The valley flashing terminates under the roof tiles in several places- Substandard installation- Water intrusion may occur, There is evidence of possible water intrusion at one or both of the valleys over the front entry- See "Exterior Surface and Components- Type", Evaluation and repairs by a qualified licensed roofing contractor are recommended

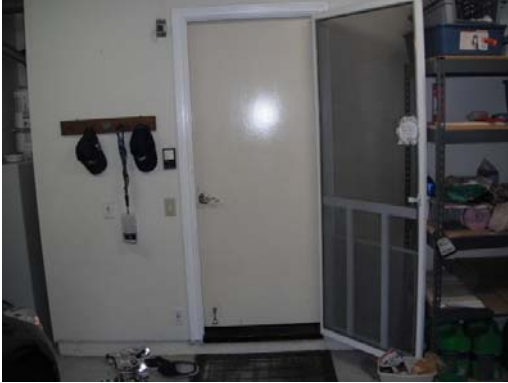
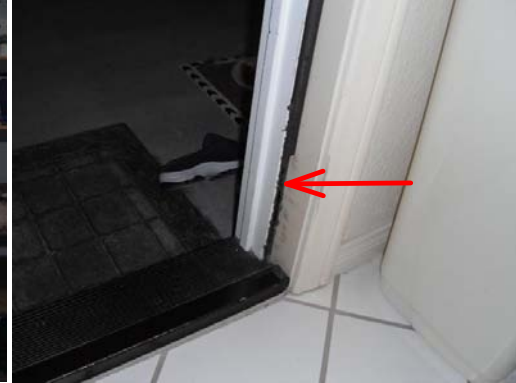
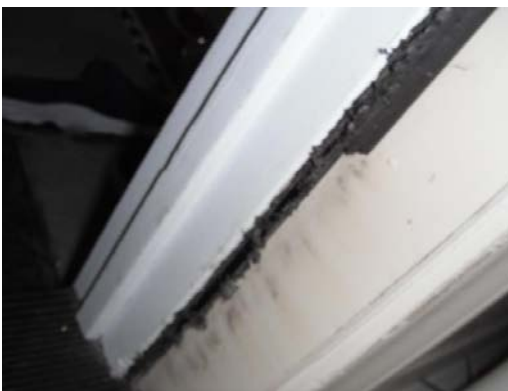
1. Type of Structure: Attached Car Spaces: 2
2. ☒ ☐ ☐ ☐ Garage Doors: Metal- sectional roll-up- Insulated
3. ☒ ☐ ☐ ☐ Door Operation: Mechanized
4. ☒ ☐ ☐ ☐ Door Opener: Lift Master
5. ☐ ☐ ☐ ☒ Fire Door: The weather-stripping at the jamb of the garage fire door (leading into the house) is damaged from a pet, causing a breach in the fire-protective barrier between the garage and the house- Fire hazard, Repairs by a qualified licensed contractor are recommended

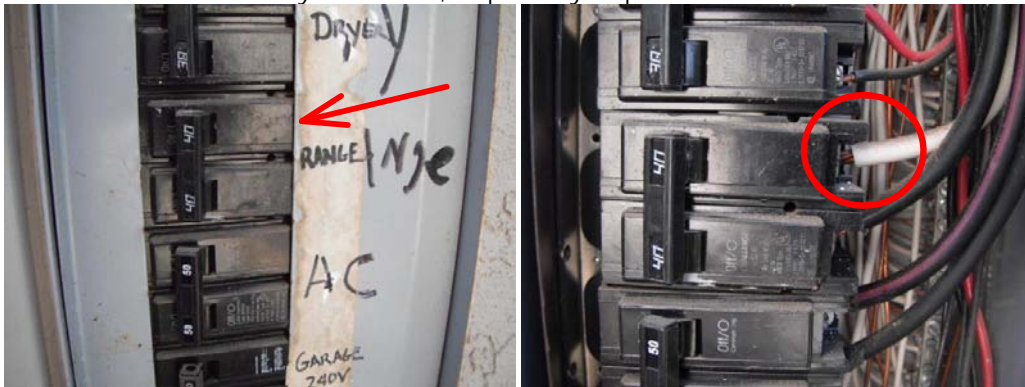
1. Service Size Amps: 200 Volts: 120/240 VAC
2. ☐ ☒ ☐ ☐ Service: Underground
3. ☒ ☐ ☐ ☐ 110 VAC Branch Circuits: Copper
4. ☐ ☐ ☐ ☒ 220 VAC Branch Circuits: The white wire connected to the 40-amp "Range" breaker in the electrical panel is not properly identified or marked as a hot wire- Substandard installation- Safety hazard- Does not meet electrical safety standards, Repairs by a qualified licensed electrician are recommended

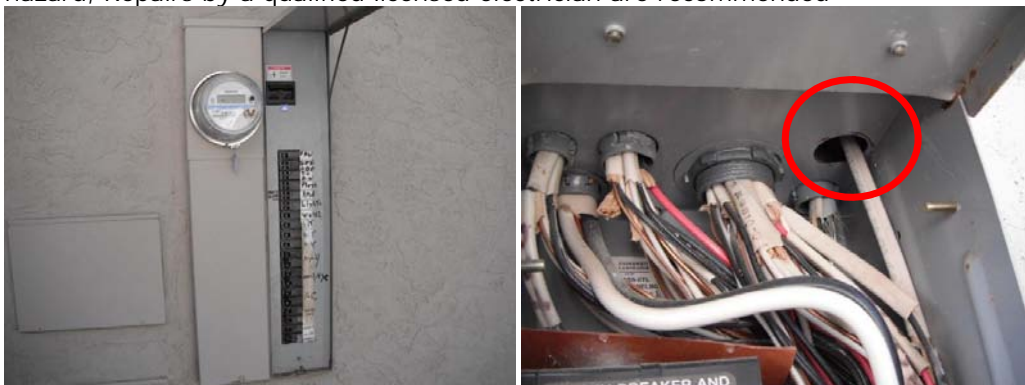
9. ☐ ☐ ☐ ☒ Manufacturer: Challenger A strain relief clamp is not installed where one of the electrical circuits enters the top of the electrical panel box- This installation does not meet electrical safety standards- Fire hazard, Repairs by a qualified licensed electrician are recommended

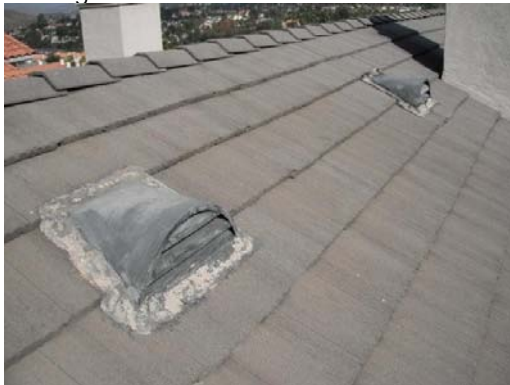
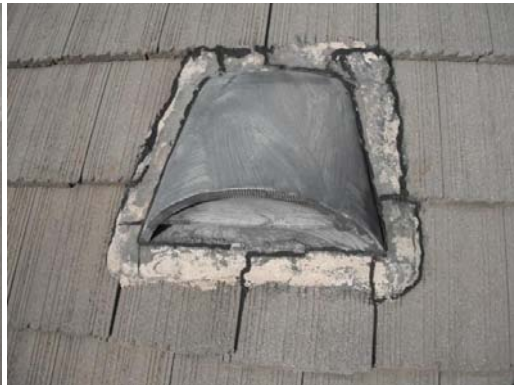
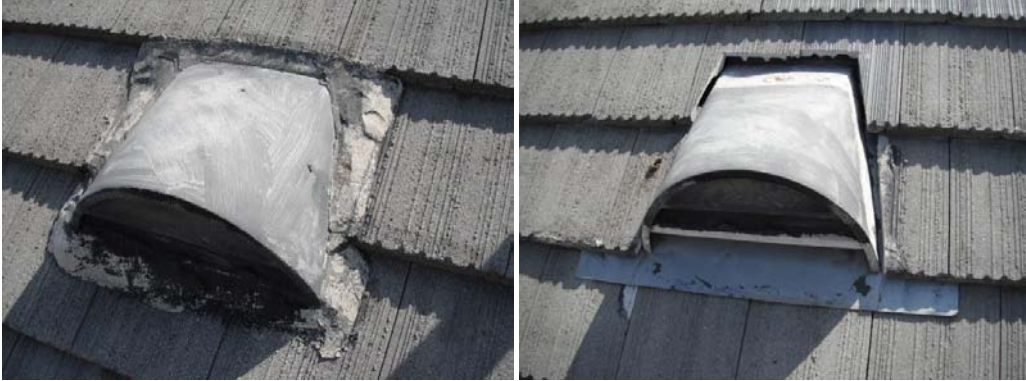
1. Method of Inspection: In the attic  
 2. ☒ ☐ ☐ ☐ Access:  
 3. ☒ ☐ ☐ ☐ Roof Framing: Wood truss  
 4. ☒ ☐ ☐ ☐ Sheathing: Plywood  
 5. ☐ ☐ ☒ ☐ Ventilation: Gable and eave vents Three of the four roof vents are flashed improperly (first three photos are incorrect)- Substandard installation- Prone to water intrusion, Repairs by a qualified licensed roofing contractor are recommended

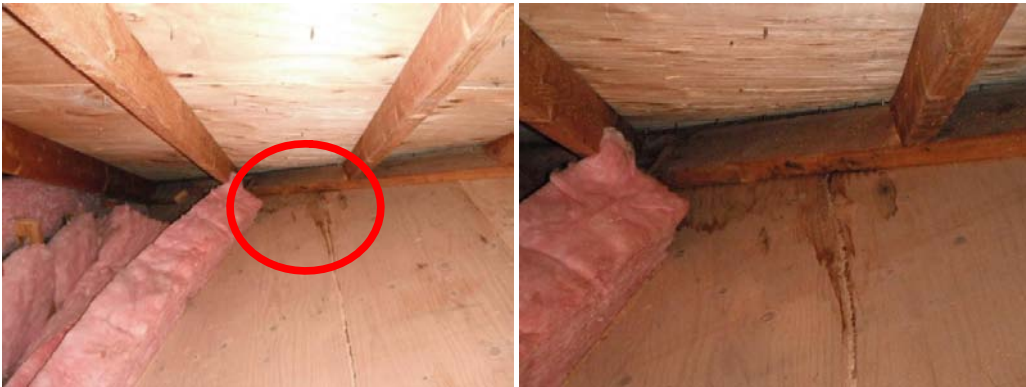
- 6. ☒ ☐ ☐ ☐ Insulation: Fiberglass batt
- 7. ☒ ☐ ☐ ☐ Insulation Depth: Approx. 6"
- 8. ☐ ☐ ☒ ☐ Moisture Penetration: Yes    Water stains are visible in the attic under the front roof valley from a past or present leak- Evaluation by a qualified licensed roofing contractor is recommended, See "Living Space-Walls"

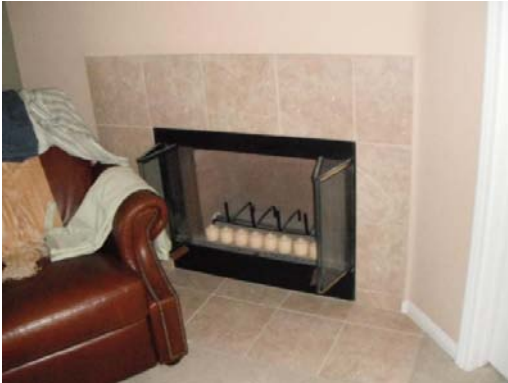
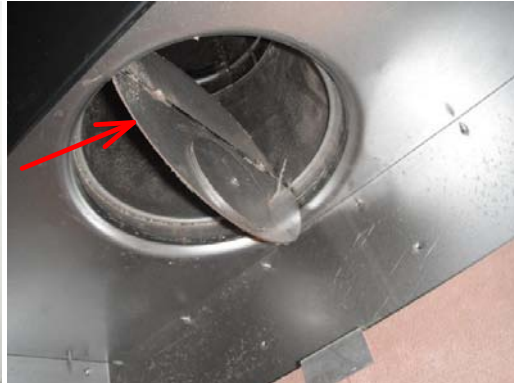
7. ☒ ☐ ☐ ☐ Fireplace Construction: Factory built
8. Type: Gas log
9. ☒ ☐ ☐ ☐ Smoke Chamber: Metal
10. ☒ ☐ ☐ ☐ Flue: Metal Not fully visible
11. ☐ ☐ ☒ ☐ Damper: A damper clamp is not installed on the fireplace damper- Safety hazard- The damper is required to be permanently blocked open in fireplaces containing a gas fixture- Installation by a qualified licensed contractor is recommended

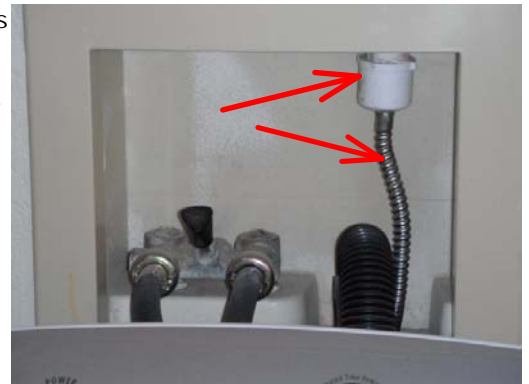
1. ☒ ☐ ☐ ☐ A/C System: Functional
2. ☐ ☐ ☒ ☐ Condensate Removal: PVC The A/C condensate drain line is reduced in size at the laundry hose bib box- Does not meet industry standards- Clogging and leakage may occur causing water damage, Repairs by a qualified licensed HVAC contractor are recommended

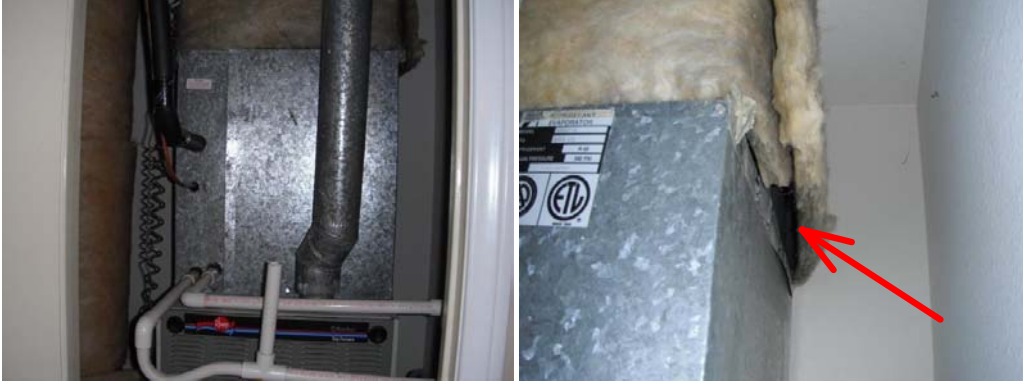
4. Fuel Type: 220-240 VAC Temperature Differential: 20
5. Type: Central A/C Capacity: 5 Ton
6. ☒ ☐ ☐ ☐ Visible Coil: Copper core with aluminum fins
7. ☒ ☐ ☐ ☐ Refrigerant Lines: Serviceable condition
8. ☒ ☐ ☐ ☐ Electrical Disconnect: Fused
9. ☐ ☐ ☒ ☐ Exposed Ductwork: There is an air leak at the top of the evaporator coil (on top of the furnace)-  
Conditioned air is being lost- Reduced efficiency of the system may occur, Repairs by a qualified licensed HVAC contractor are recommended

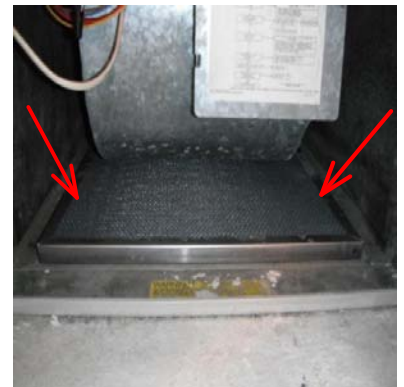
1. ☒ ☐ ☐ ☐ Heating System: Functional
2. Manufacturer: Rheem
3. Type: Forced air unit Capacity: 100,000 BTU
4. Fuel Type: Natural gas
5. ☐ ☒ ☐ ☐ Heat Exchanger: 4 Burner
6. ☐ ☐ ☒ ☐ Blower Fan/Filters: The hold-down for the furnace air filter is missing-  
Dirt and dust can bypass the filter resulting in reduced efficiency and shortened life-span of the unit, Repairs by a qualified licensed HVAC contractor are recommended

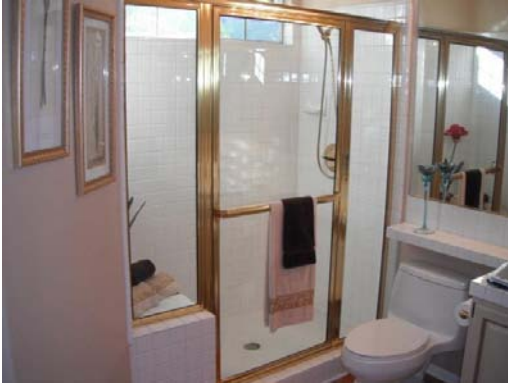
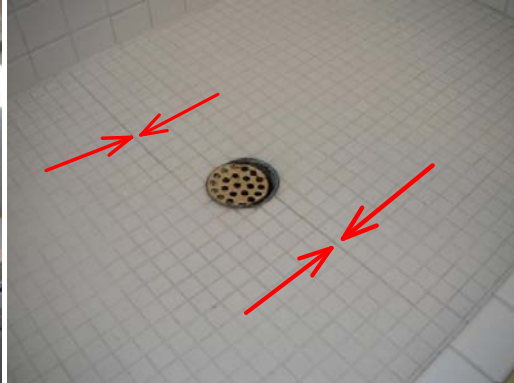
1. ☒ ☐ ☐ ☐ Ceiling: Drywall
2. ☒ ☐ ☐ ☐ Walls: Drywall
3. ☒ ☐ ☐ ☐ Floor: Hardwood
4. ☒ ☐ ☐ ☐ Doors: Hollow core
5. ☒ ☐ ☐ ☐ Windows: Metal with dual-pane glass
6. ☒ ☐ ☐ ☐ Electrical: 110 VAC GFCI outlets, Lighting
7. ☒ ☐ ☐ ☐ Counter Top: Tile
8. ☒ ☐ ☐ ☐ Cabinets: Wood
9. ☒ ☐ ☐ ☐ Sinks: Porcelain single-bowl
10. ☒ ☐ ☐ ☐ Plumbing/Fixtures:
11. ☐ ☐ ☒ ☐ Shower: Tile There is a crack running through the shower pan- Water penetration may occur- Evaluation by a qualified shower pan specialist is recommended, The drain cover is loose- Prone to clogging- Repairs by a qualified licensed plumber are recommended

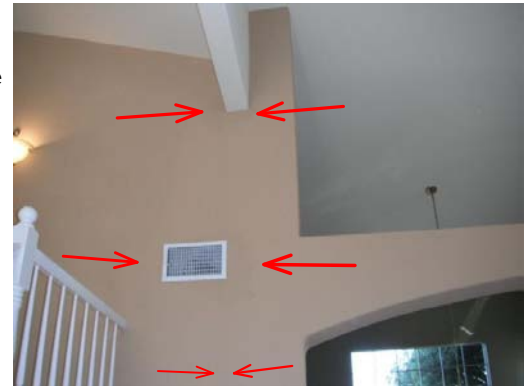
1. ☒ ☐ ☐ ☐ Closets:  
 2. ☒ ☐ ☐ ☐ Ceilings: Drywall  
 3. ☐ ☐ ☒ ☐ Walls: Water staining is visible on the living room wall below the ceiling beam from a past or present roof leak- Evaluation by a qualified licensed roofing contractor is recommended, See "Attic- Moisture Penetration"

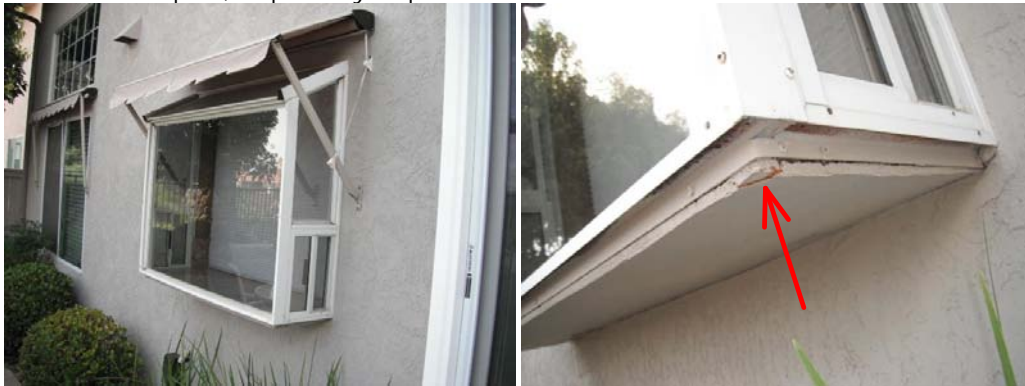
1. ☒ ☐ ☐ ☐ Cooking Appliances: Maytag, General Electric
2. ☒ ☐ ☐ ☐ Ventilator: General Electric
3. ☒ ☐ ☐ ☐ Disposal: In-Sinkerator
4. ☒ ☐ ☐ ☐ Dishwasher: General Electric
5. Air Gap Present? ☒ Yes ☐ No
6. ☒ ☐ ☐ ☐ Microwave: General Electric
7. ☒ ☐ ☐ ☐ Sink: Enamelized steel dual-bowl
8. ☒ ☐ ☐ ☐ Electrical: 110 VAC GFCI outlets, Lighting
9. ☒ ☐ ☐ ☐ Plumbing/Fixtures:
10. ☒ ☐ ☐ ☐ Counter Top: Granite
11. ☒ ☐ ☐ ☐ Cabinets: Wood
12. ☒ ☐ ☐ ☐ Pantry:
13. ☒ ☐ ☐ ☐ Ceiling: Drywall
14. ☒ ☐ ☐ ☐ Walls: Drywall
15. ☒ ☐ ☐ ☐ Floor: Hardwood
16. ☒ ☐ ☐ ☐ Doors: Hollow core
17. ☐ ☐ ☒ ☐ Windows: The exterior wood at the bottom of the kitchen garden window is moisture-damaged- Refer to the termite report, Repairs by a qualified licensed window contractor are recommended

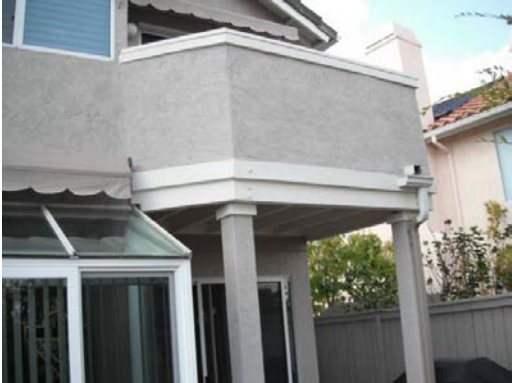
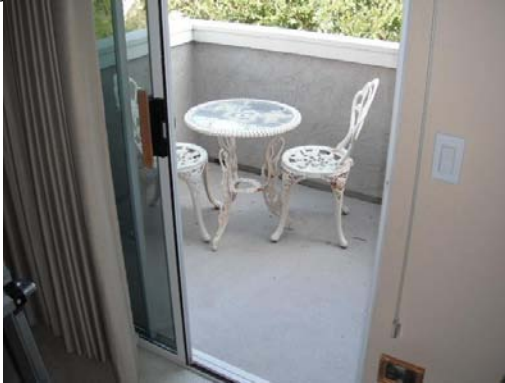
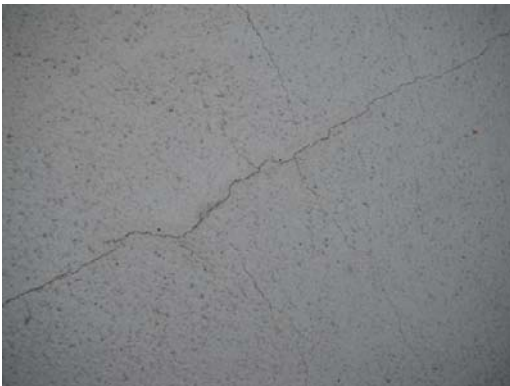
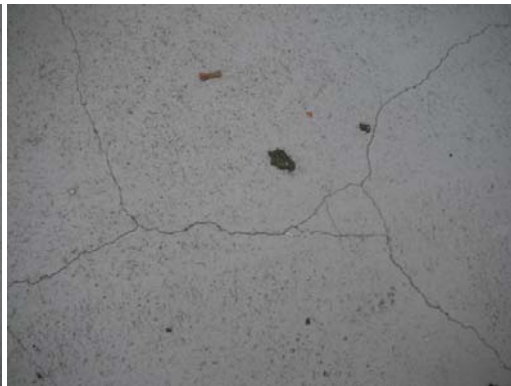
1. Balcony: Polymer coated    The waterproof membrane at the balcony decking is cracked open- Prone to water penetration, Evaluation and repairs by a qualified licensed deck/balcony specialist are recommended

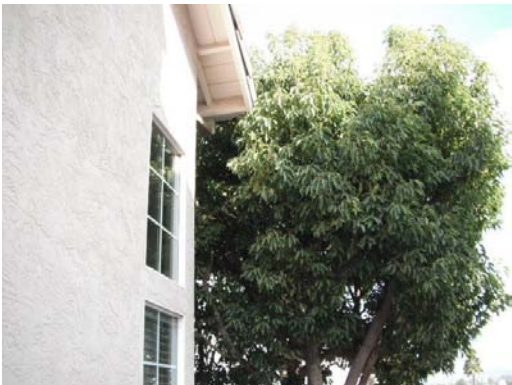
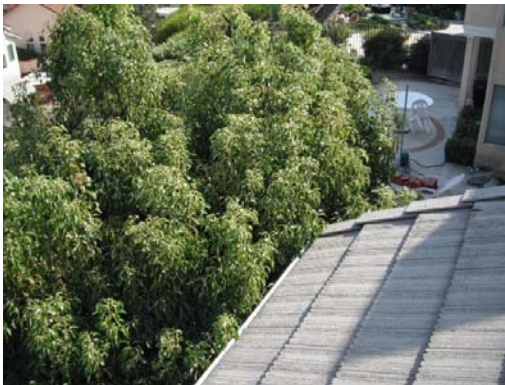
2. Vegetation: The tree limbs hang over the rear corner of the roof- Pruning by a qualified licensed arborist is recommended to prevent damage to the roofing material, and to prevent insect and rodent access into the house

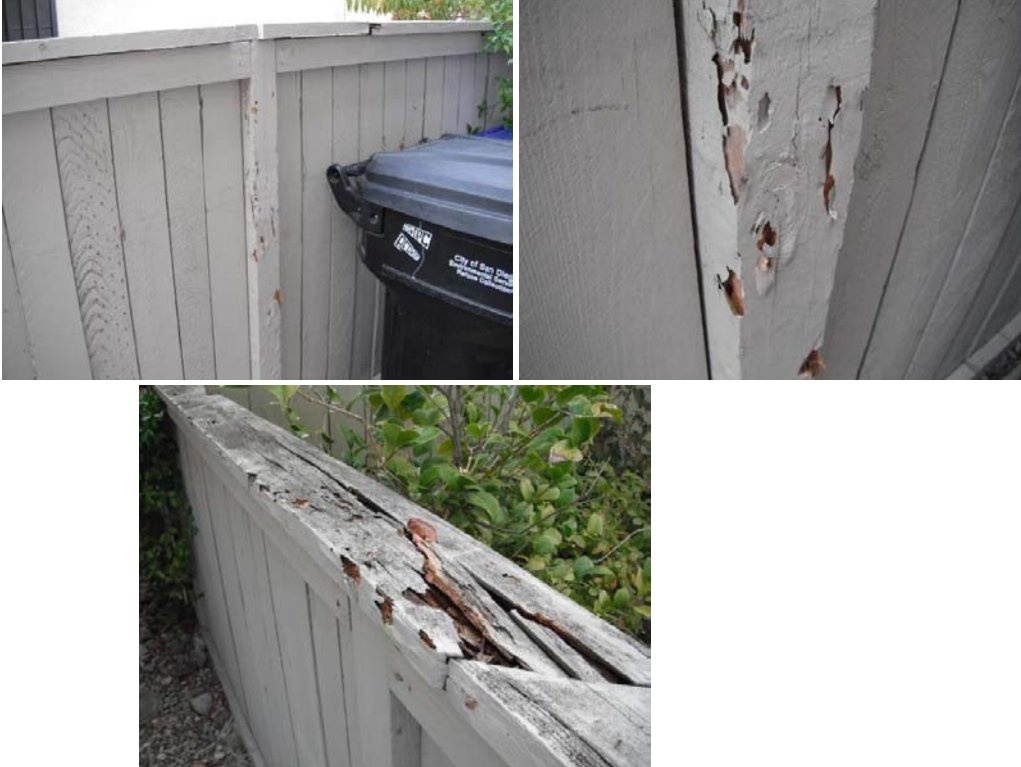
3. Fences: Wood, Metal    There is dry rot and wood-destroying pest damage in the components of the wood fence at the left side of the lot, Repairs by a qualified licensed contractor are recommended

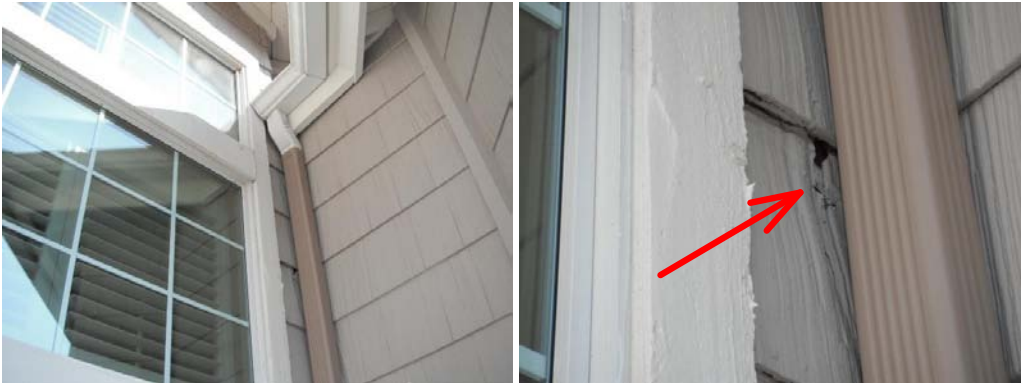
4. Exterior Surface Type: Stucco, Wood shingles There is moisture damage and dry rot in the wood shingles behind the gutter downspout by the front entry- Refer to the termite report, Repairs by a qualified licensed contractor are recommended

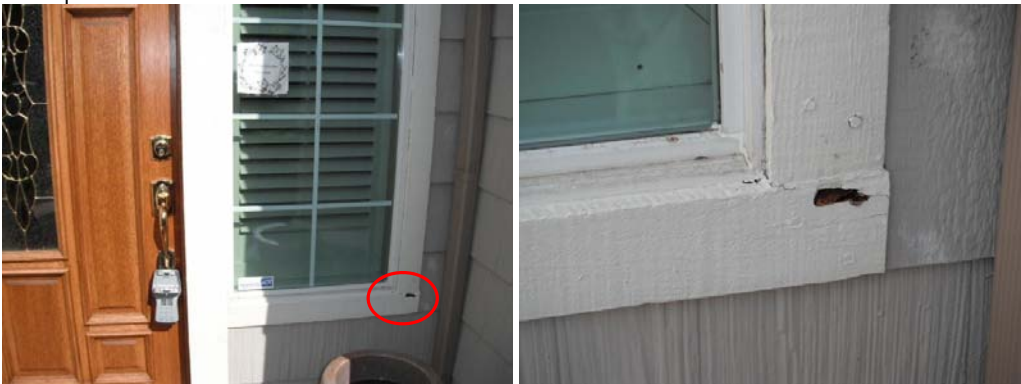
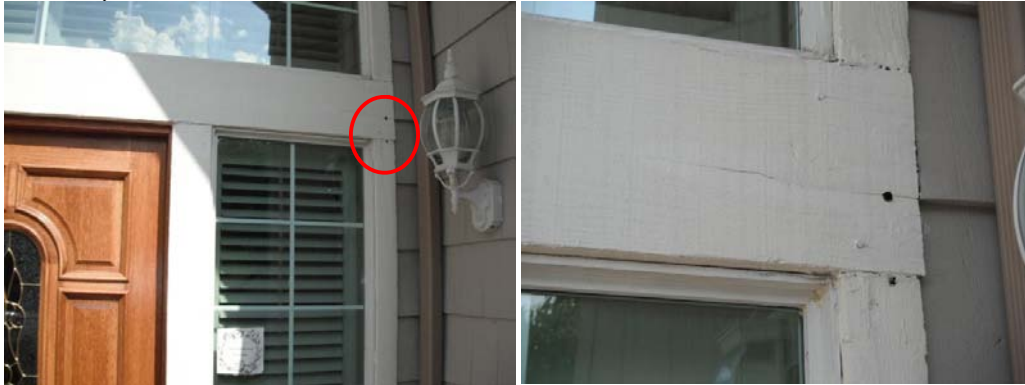
5. Trim: Wood There is dry rot in the window trim at the front entry, Refer to the termite report, Repairs by a qualified licensed contractor are recommended

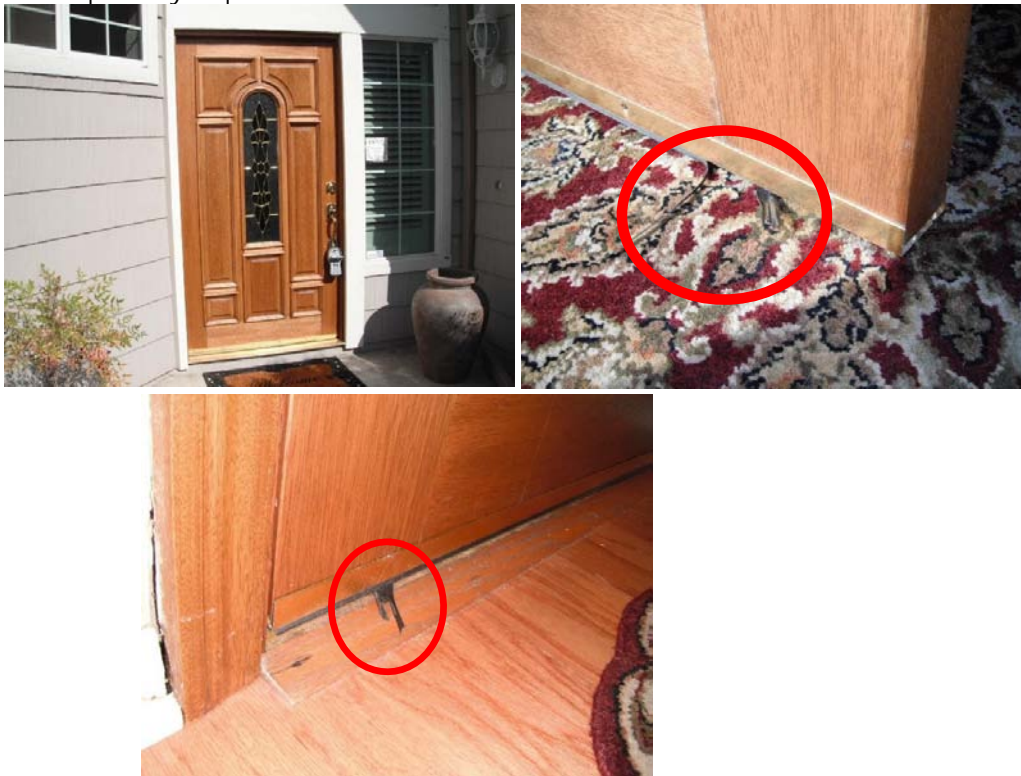
6. Entry Door: Wood The weather seal at the bottom of the front entry door is torn- Water intrusion may occur, Repairs by a qualified licensed contractor are recommended

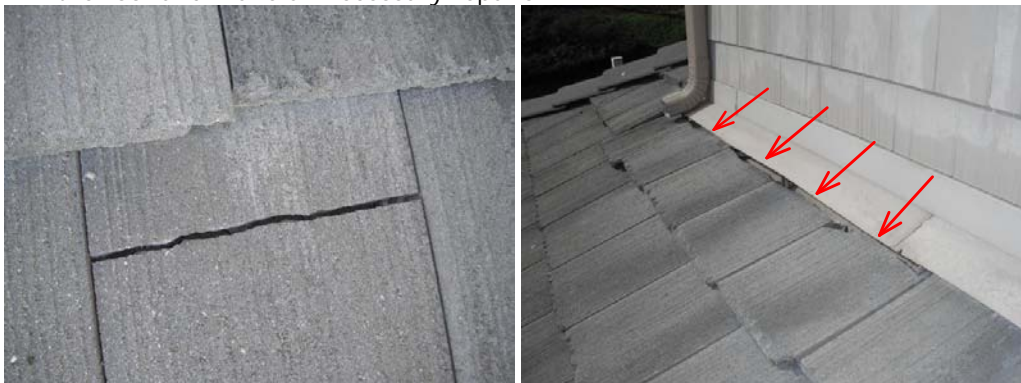
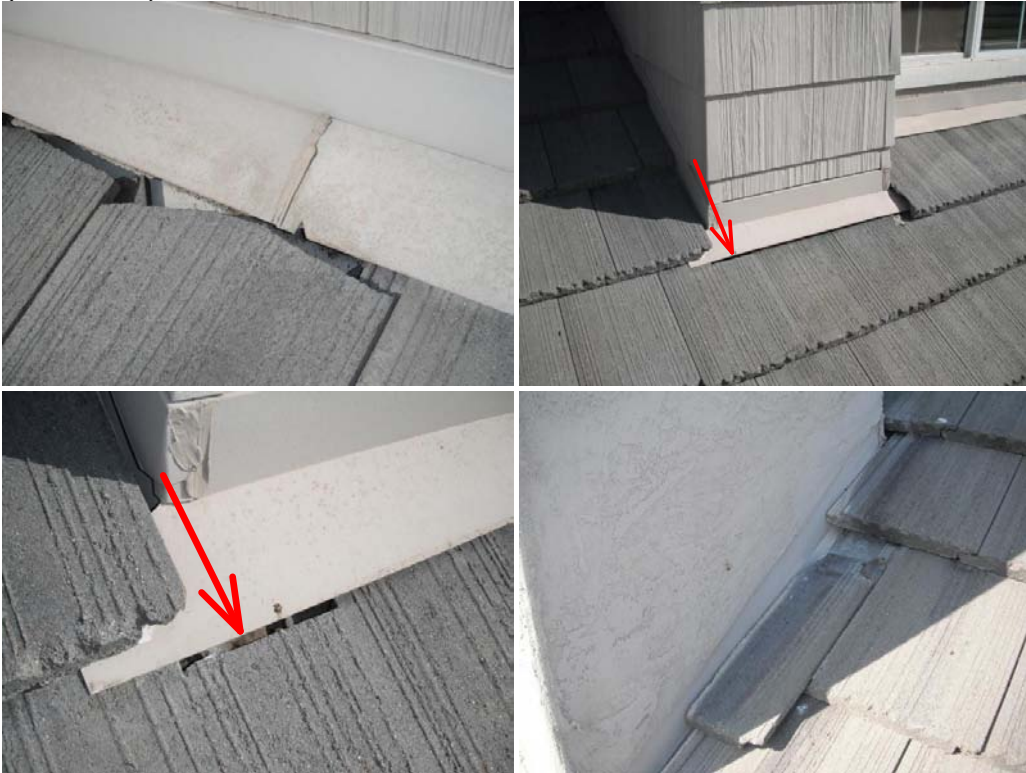
7. Roof Surface Material: Concrete tile There are several broken and/or loose tiles on the roof at various locations- Water intrusion and roof leakage may occur, A qualified licensed roofing contractor is recommended to evaluate the roof and make all necessary repairs

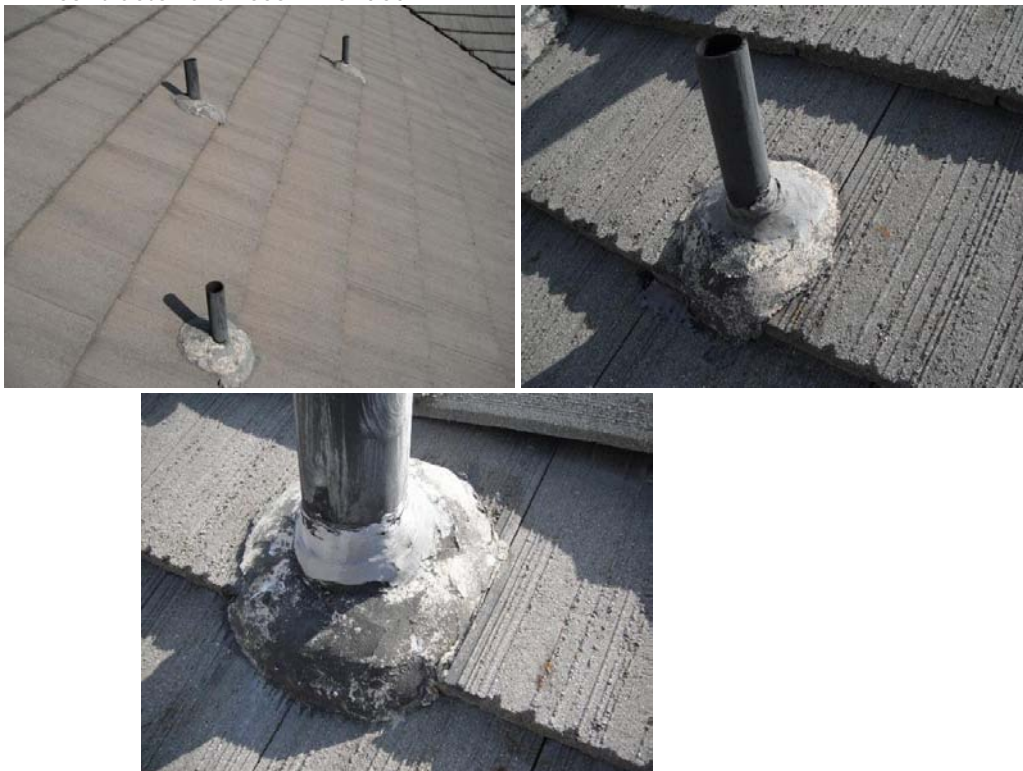
8. Flashing: Lack of metal flashing was noted at the roof penetrations (mortar used- prone to crack and leak)- Substandard installation- Prone to water penetration, Upgrades to metal flashing by a qualified licensed roofing contractor are recommended

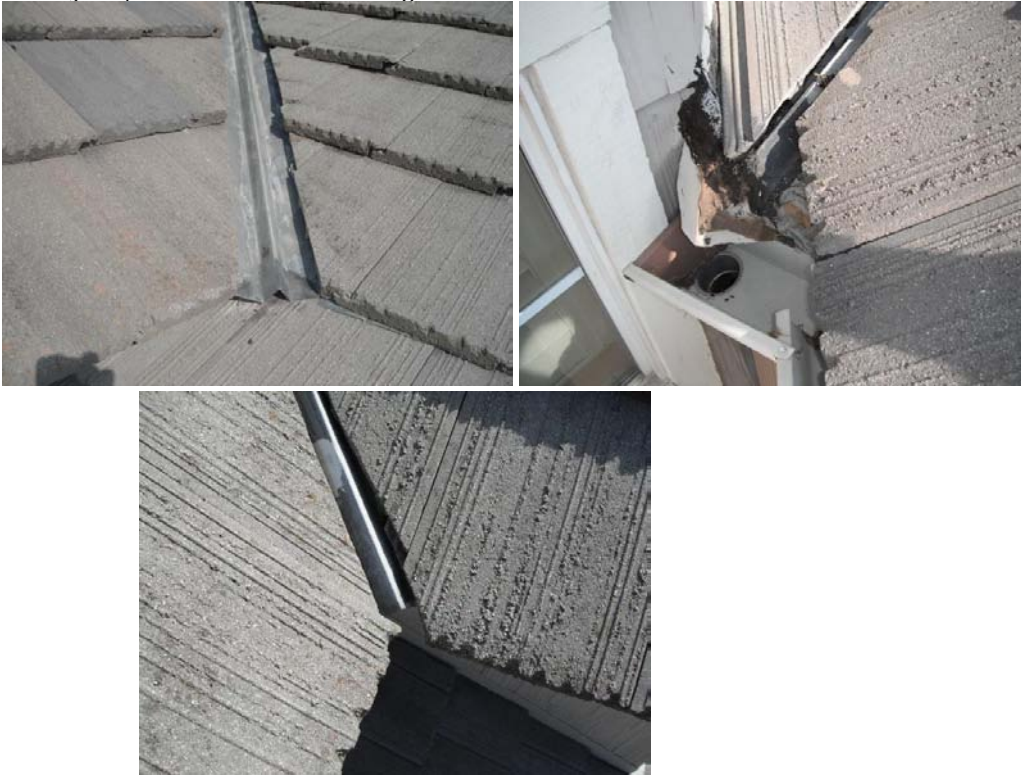
9. Valleys: Pre-formed galvanized metal The valley flashing terminates under the roof tiles in several places- Substandard installation- Water intrusion may occur, There is evidence of possible water intrusion at one or both of the valleys over the front entry- See "Exterior Surface and Components- Type", Evaluation and repairs

Valleys: (continued)  
by a qualified licensed roofing contractor are recommended

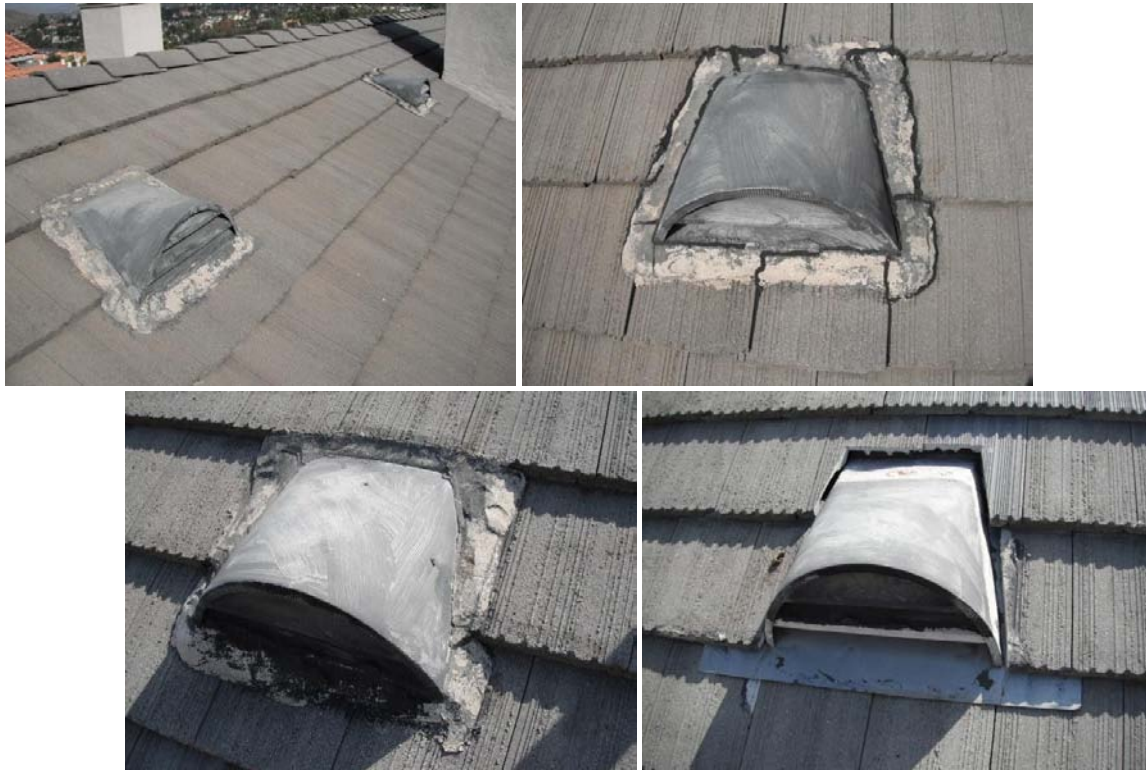
10. Attic Ventilation: Gable and eave vents Three of the four roof vents are flashed improperly (first three photos are incorrect)- Substandard installation- Prone to water intrusion, Repairs by a qualified licensed roofing contractor are recommended

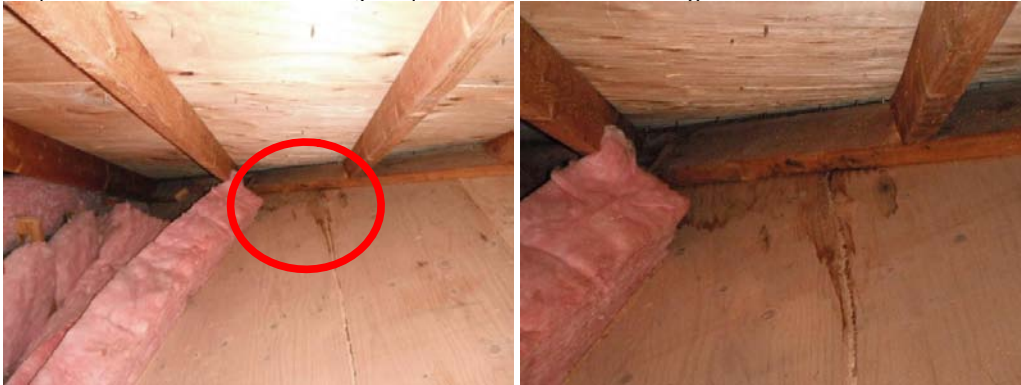
11. Attic Moisture Penetration: Yes Water stains are visible in the attic under the front roof valley from a past or present leak- Evaluation by a qualified licensed roofing contractor is recommended, See "Living Space- Walls"

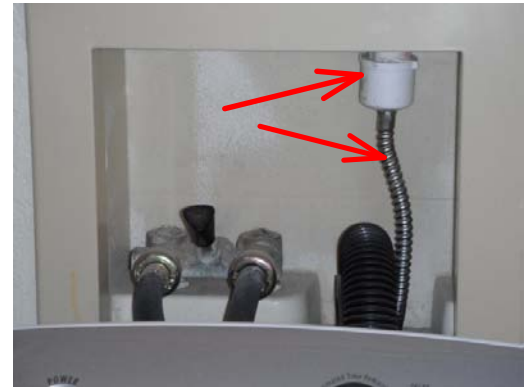
12. AC System Condensate Removal: PVC The A/C condensate drain line is reduced in size at the laundry hose bib box- Does not meet industry standards- Clogging and leakage may occur causing water damage, Repairs by a qualified licensed HVAC contractor are recommended

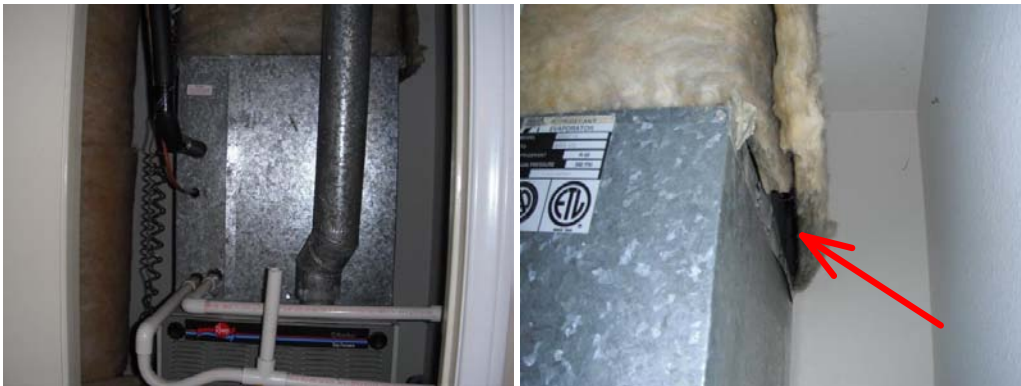
13. Exposed Ductwork: There is an air leak at the top of the evaporator coil (on top of the furnace)- Conditioned air is being lost- Reduced efficiency of the system may occur, Repairs by a qualified licensed HVAC contractor are recommended
