**FIRST CHOICE**  
Inspections

# Property Inspection Report

17763 ABC Court  
San Diego, CA 92131

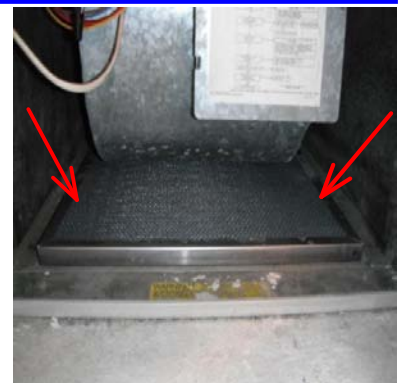
14. Heating System Blower Fan/Filters: The hold-down for the furnace air filter is missing- Dirt and dust can bypass the filter resulting in reduced efficiency and shortened life-span of the unit, Repairs by a qualified licensed HVAC contractor are recommended

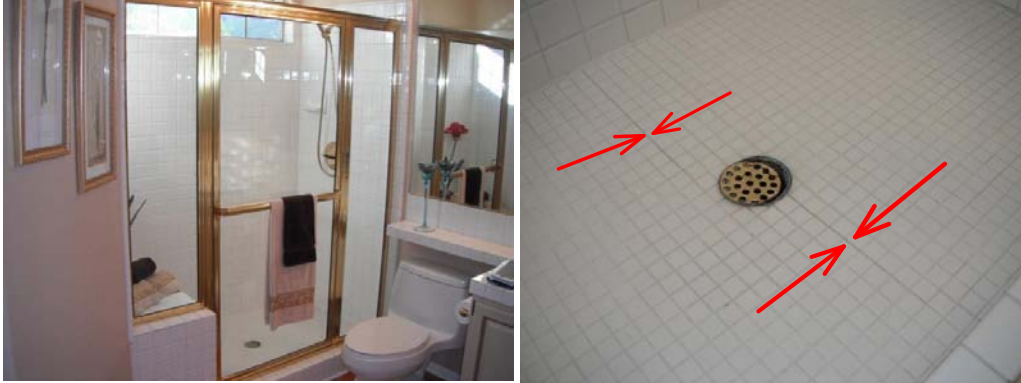
15. 1st Floor Bathroom Shower: Tile There is a crack running through the shower pan- Water penetration may occur- Evaluation by a qualified shower pan specialist is recommended, The drain cover is loose- Prone to clogging- Repairs by a qualified licensed plumber are recommended

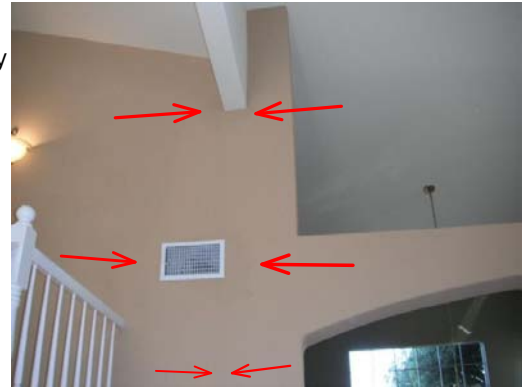
16. Living Space Walls: Water staining is visible on the living room wall below the ceiling beam from a past or present roof leak- Evaluation by a qualified licensed roofing contractor is recommended, See "Attic-Moisture Penetration"

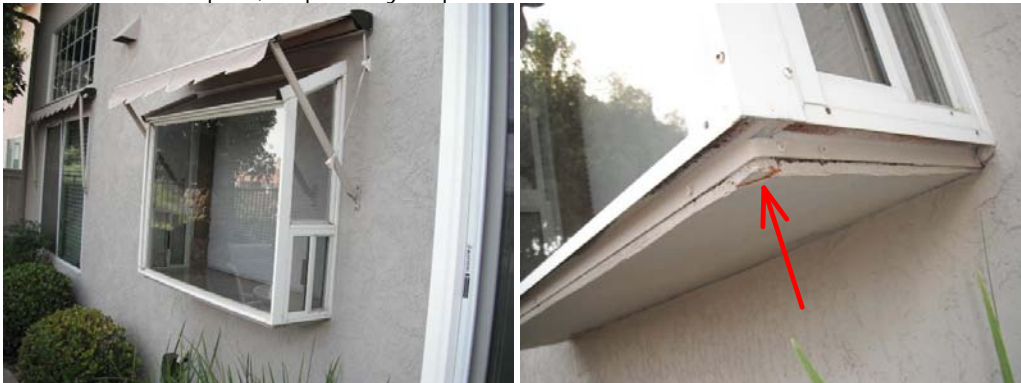
17. Kitchen Windows: The exterior wood at the bottom of the kitchen garden window is moisture-damaged- Refer to the termite report, Repairs by a qualified licensed window contractor are recommended

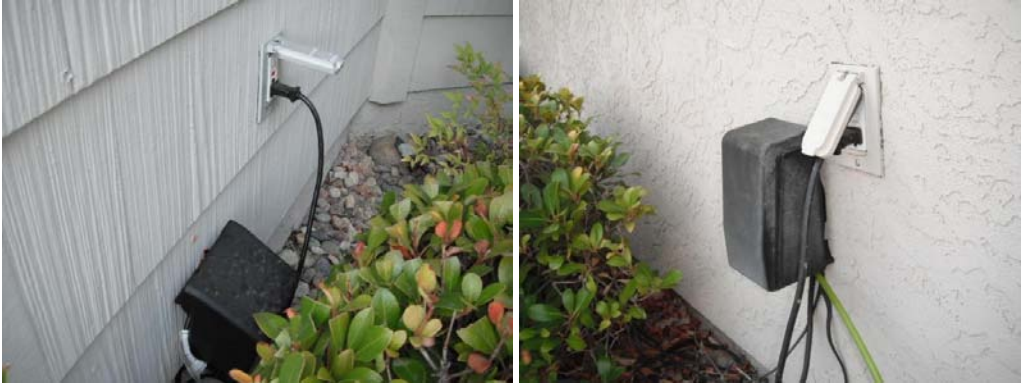
1. Exterior Electric Outlets: An "in-use" cover is not installed on the exterior electrical outlets used by the timer boxes- Prone to water intrusion- Fire/Shock hazard, Repairs by a qualified licensed electrician are recommended

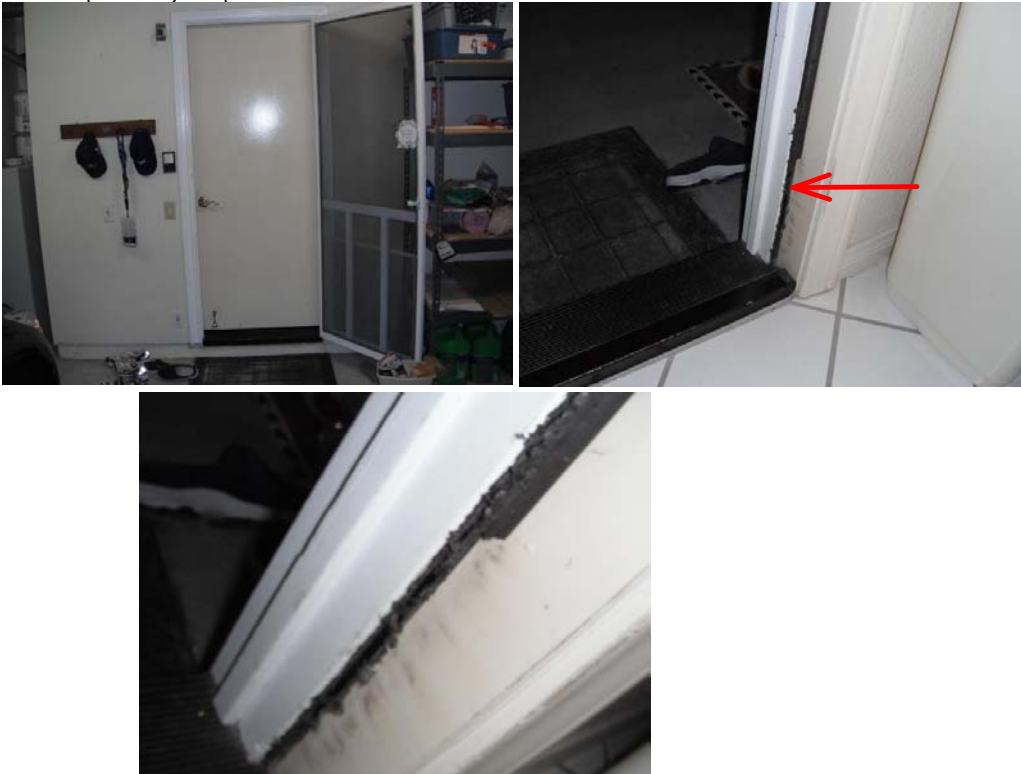
2. Garage Fire Door: The weather-stripping at the jamb of the garage fire door (leading into the house) is damaged from a pet, causing a breach in the fire-protective barrier between the garage and the house- Fire hazard, Repairs by a qualified licensed contractor are recommended

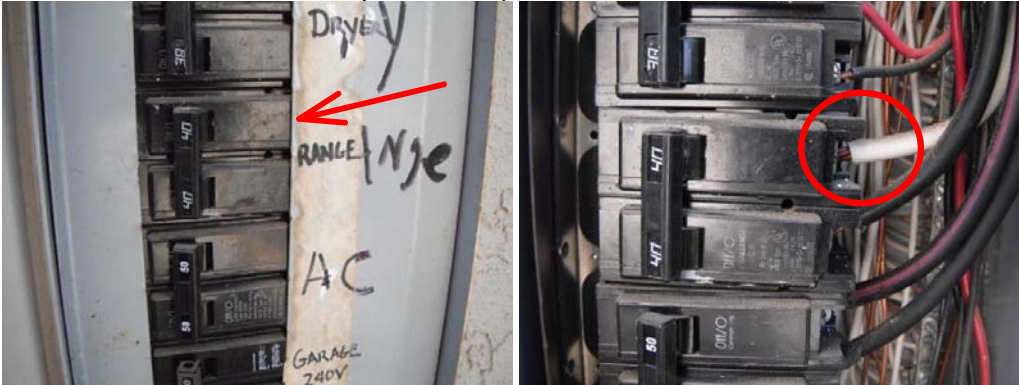
3. 220 VAC Branch Circuits: The white wire connected to the 40-amp "Range" breaker in the electrical panel is not properly identified or marked as a hot wire- Substandard installation- Safety hazard- Does not meet electrical safety standards, Repairs by a qualified licensed electrician are recommended

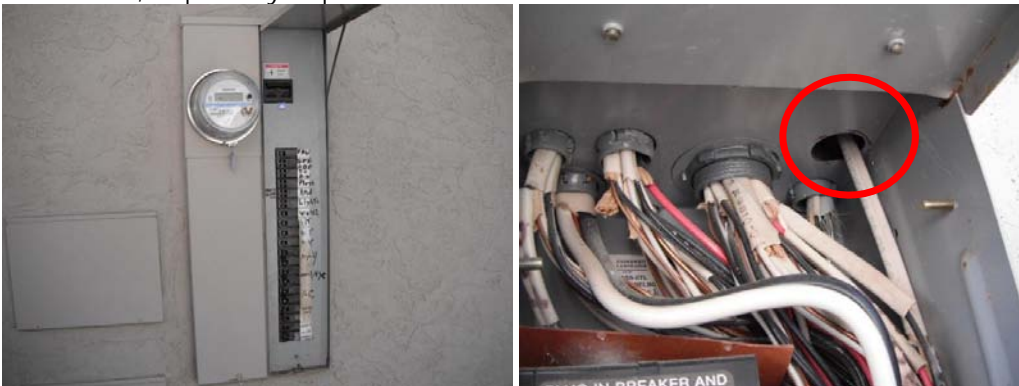
4. Electric Panel Manufacturer: Challenger A strain relief clamp is not installed where one of the electrical circuits enters the top of the electrical panel box- This installation does not meet electrical safety standards- Fire hazard, Repairs by a qualified licensed electrician are recommended

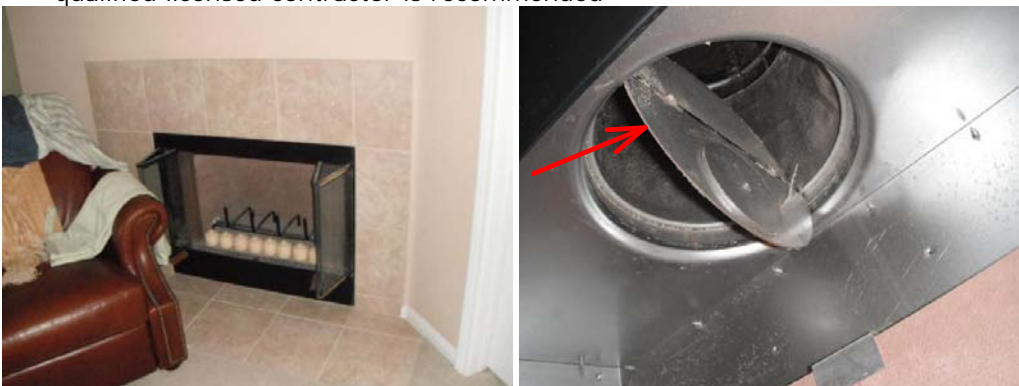
5. Master Bedroom Fireplace Damper: A damper clamp is not installed on the fireplace damper- Safety hazard- The damper is required to be permanently blocked open in fireplaces containing a gas fixture- Installation by a qualified licensed contractor is recommended
