Hazards of the Consolidated Industries H-Series Horizontal Atmospheric Furnace

By Michael Whedon
Licensed, Certified, Private Fire Investigator.

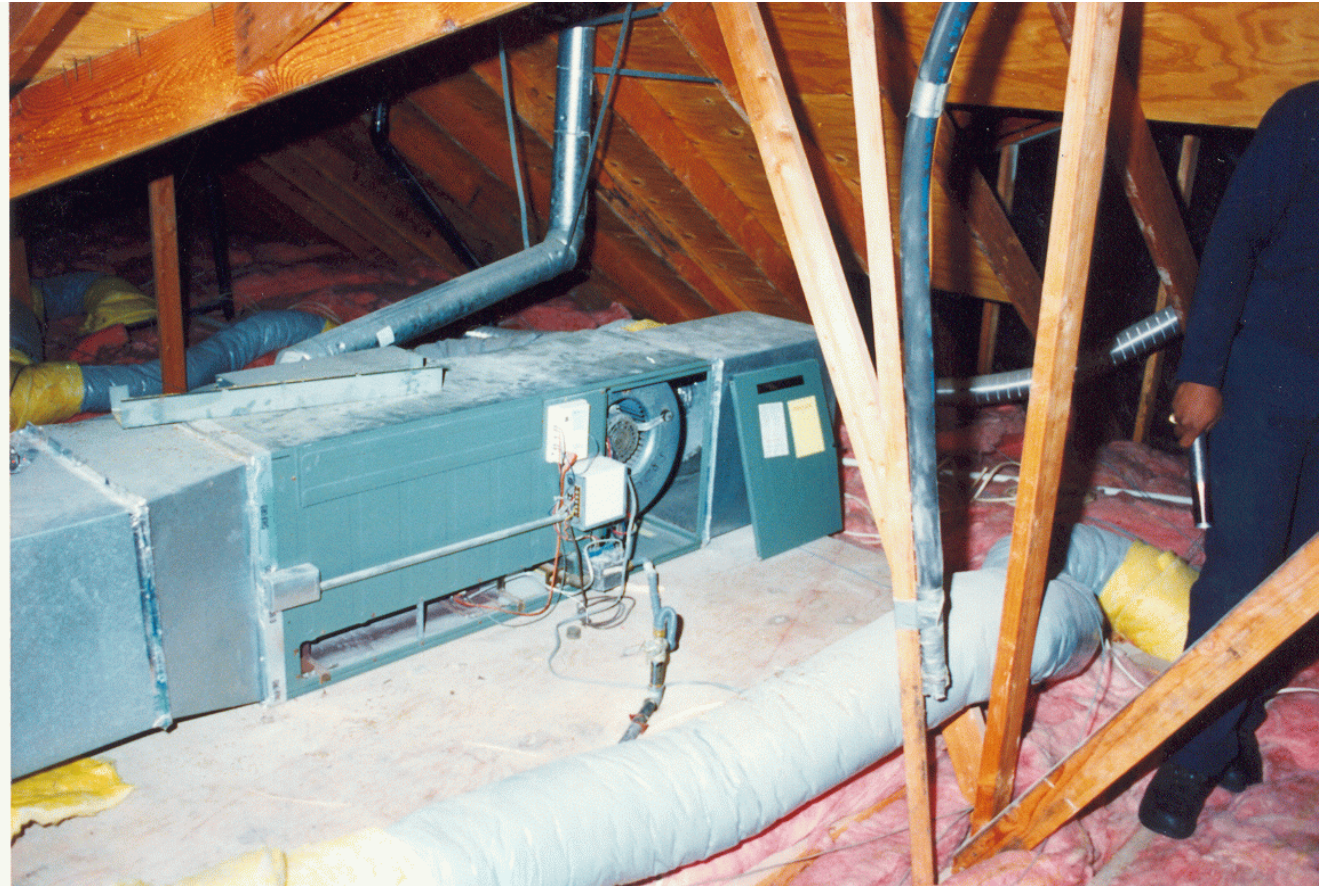
Photo One: Typical installation method for H-Series furnace.

During the same time period, fire investigators began to see an increase in fires occurring in homes equipped with the Consolidated H-Series furnaces. These Consolidated furnaces had been installed in attic spaces on plywood decks or set perpendicular across wooden ceiling joists. The initial theorization was that although the furnaces were rated for installation on combustible surfaces, heat was passing from the burner compartment through the bottom panel of the furnace and igniting the wood decking or joists below. The official fire cause was listed as "pyrolysis," which is simply the decomposition of a fuel due to heat. Not realizing the commonality of the furnaces involved in the problem, some fire department and building department in a joint effort began requiring that all horizontal furnaces installed in attics be placed on non-combustible flooring.

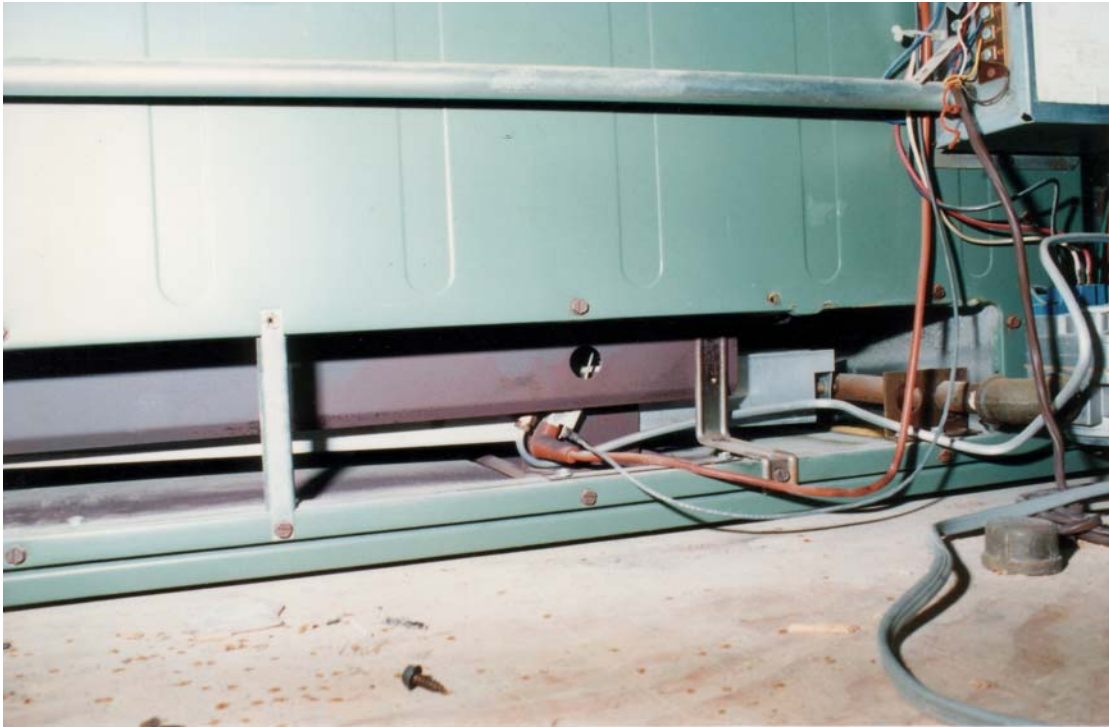
Photo Two: Combustion air intake port at bottom edge of furnace housing.

The second life threatening condition is the fire hazard. During the operation of a damaged furnace, if sufficient amounts of circulation air enters the combustion chamber, through holes in the heat exchanger, the burner flames can be pushed down against the bottom panel of the furnace housing as well as out the sides of the furnace through the combustion air intake openings. The combustion air intake openings are located along the sides of the furnace just above the bottom edge. This movement of flames and hot combustion gases out of the furnace is called "flame roll out."

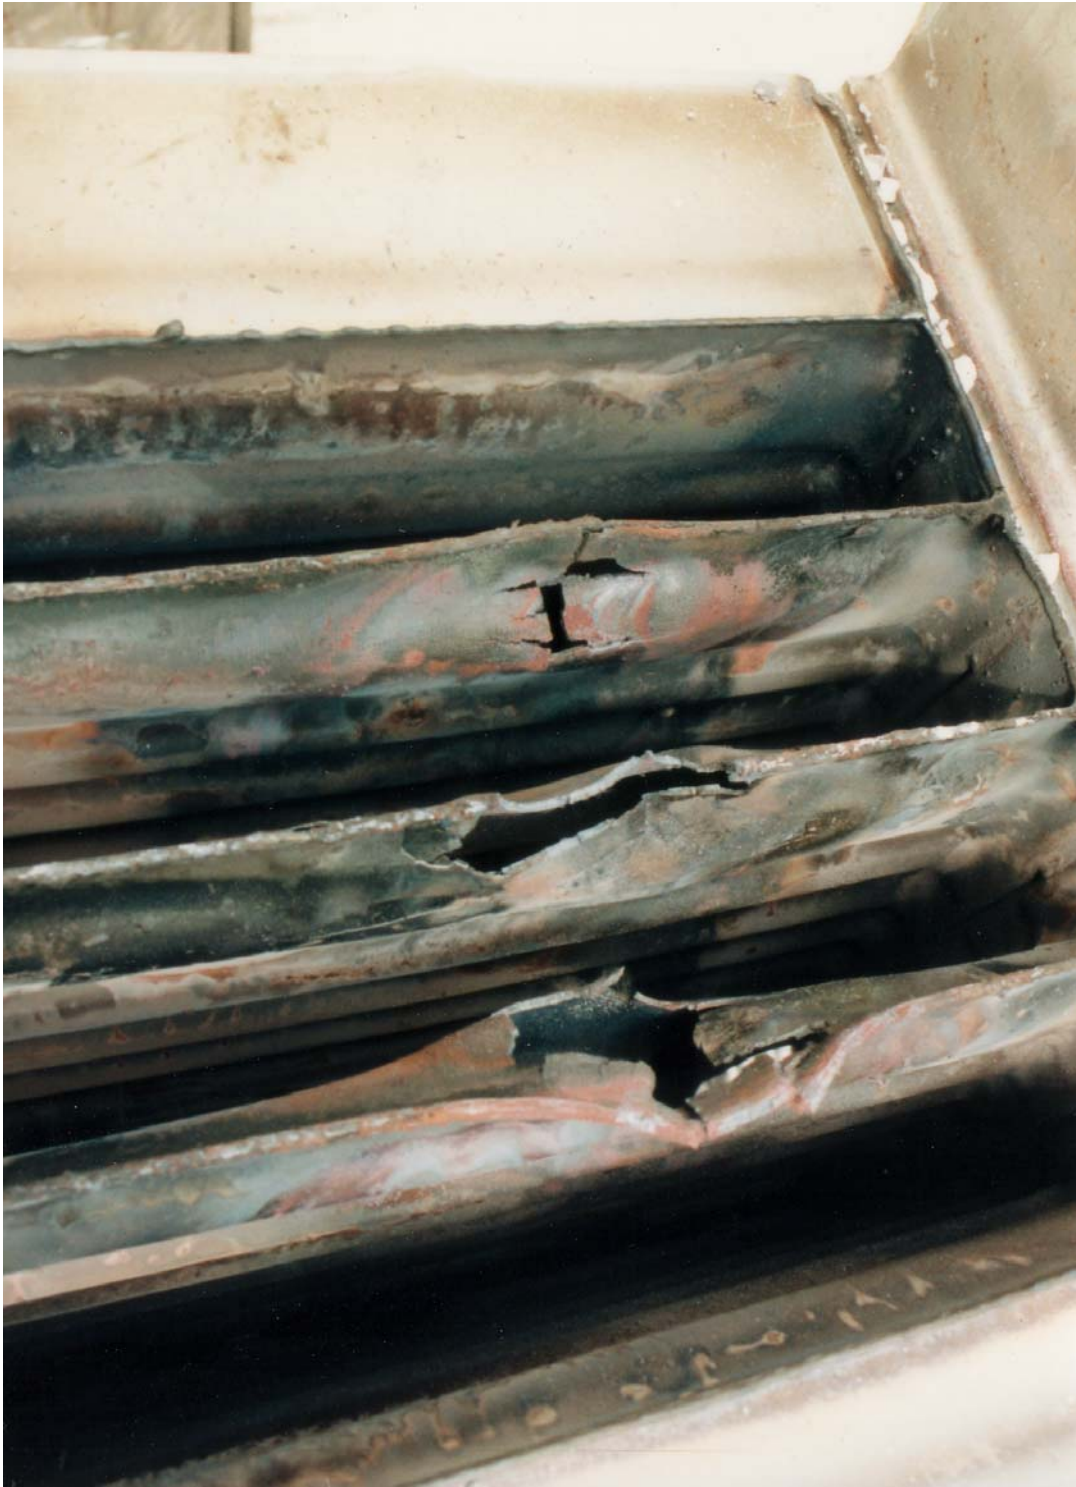
Photo Six: Failed heat exchanger.

Heat exchangers are made of 18 gauge stamped steel which is machine welded together to form cells or tubes. The purpose of the heat exchanger is to warm the air passing through the furnace before it is discharged into the duct system for distribution into the living space of the house. The metal from which the heat exchanger is formed did not have the ability to withstand the direct impingement of the flames from the damaged burners. Additionally, the weld seams themselves, located along the bottom of the heat exchanger tubes, were also being subjected to this direct flame impingement. These weld seams, which are of relatively poor quality, would fail quickly when exposed to the direct flame contact. Lateral cracks would begin to form in the weld seams leading to horizontal cracks in the walls of the heat exchanger cells. Under continued use, these cracks widen and grow in length.

Eventually the metal crystallizes and begins to literally fall apart. This results in holes appearing in the heat exchanger cells. The holes continue to grow larger in size each time the furnace is used.

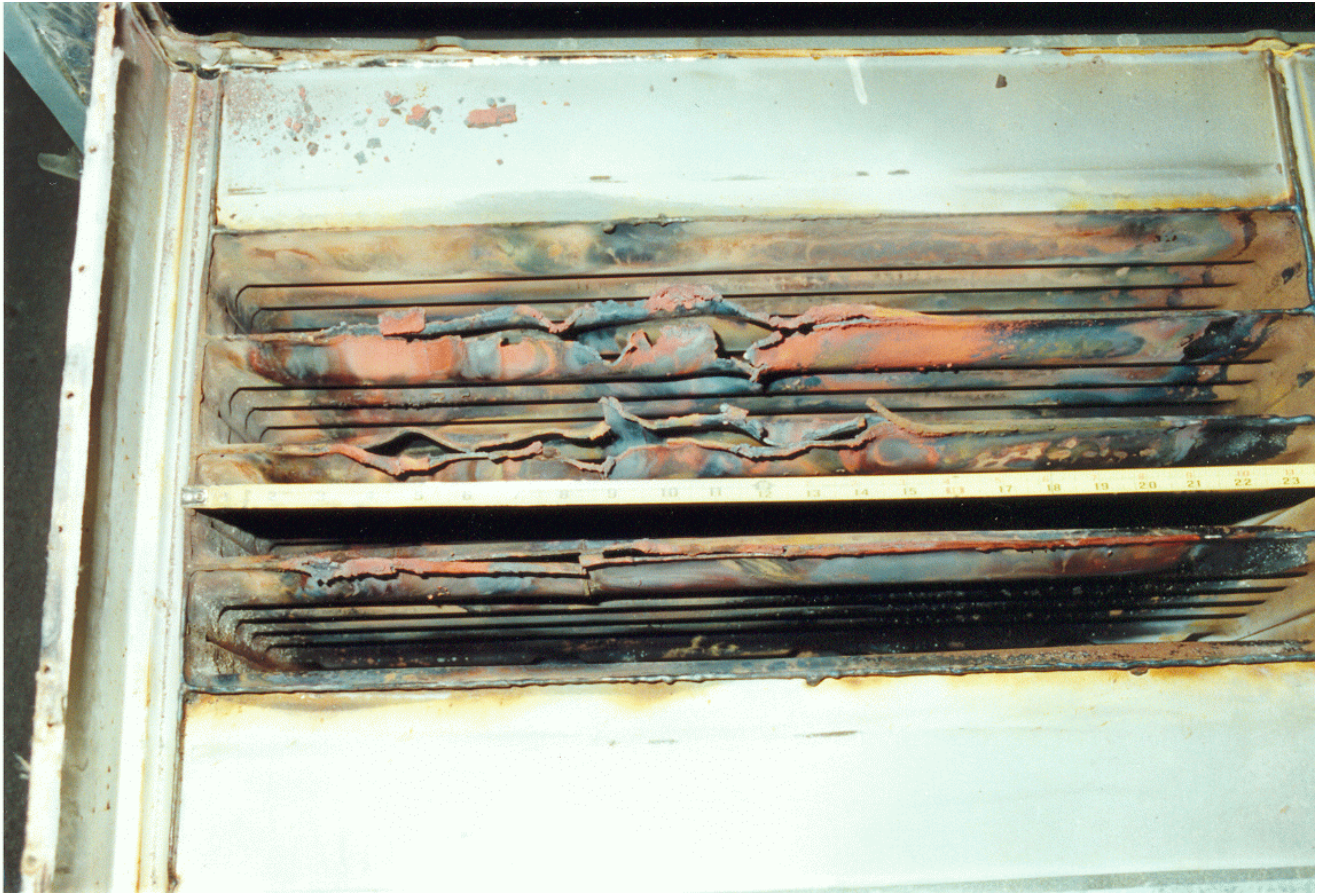
Photo Seven: Major failure of heat exchanger.

If you have a horizontal furnace in your residence that was manufactured by Consolidated Industries, I strongly suggest you consider replacing the furnace immediately. If it has not already failed, **it will fail.** It is simply a question of when. An visual inspection of the furnace will only reveal the most obvious damage. Microscopic cracks in the heat exchanger, especially in the weld seams, are very difficult to detect. However, during use of the furnace the small cracks will expand in size due to expansion of the metal. The furnace may look fine today and crack the very next time it is used. If your furnace shows any signs of internal damage, do not use it, even for a few minutes. **Replace it immediately.** Replacing the burner assembly and/or the heat exchanger does not solve the problem. It merely replaces improperly designed and manufactured parts that will fail again, perhaps with catastrophic results.
