# Property Inspection Report

**41999 Best St.  
Carlsbad, CA 92010**

**Inspector: Steve Stenros**  
**888-335-3040**  
**steve@firstchoiceinspect.com**

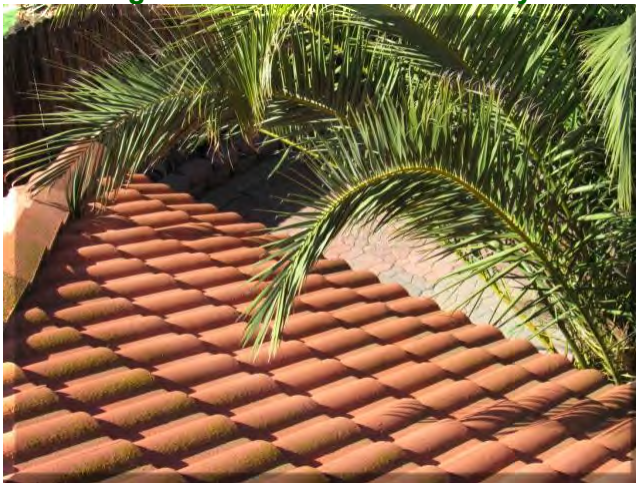
1. The tree branches are growing against the home and hang over the roof. Structural damage and/or rodent access may occur. Pruning is recommended.

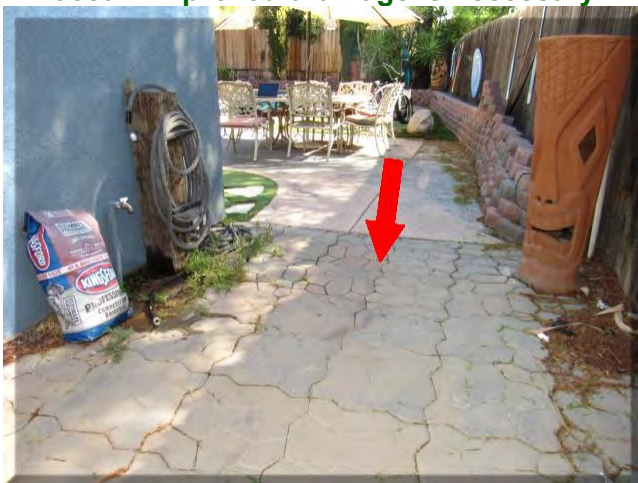
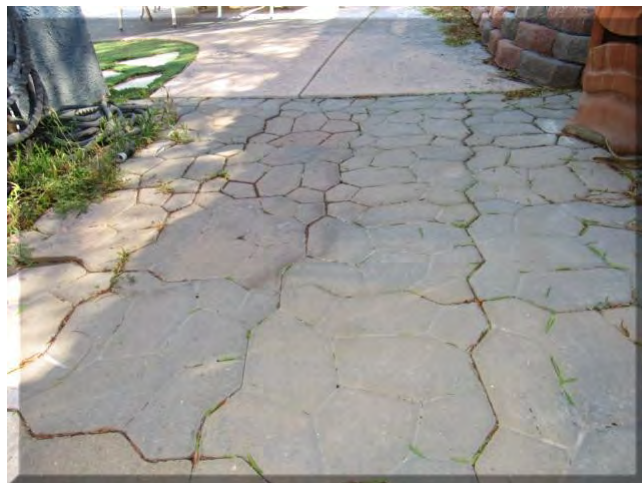
2. An area of poor drainage was noted where the paver walkway at the rear right corner of the home meets the patio slab. Ponding water and/or excessive moisture conditions may occur. Improved drainage is necessary.

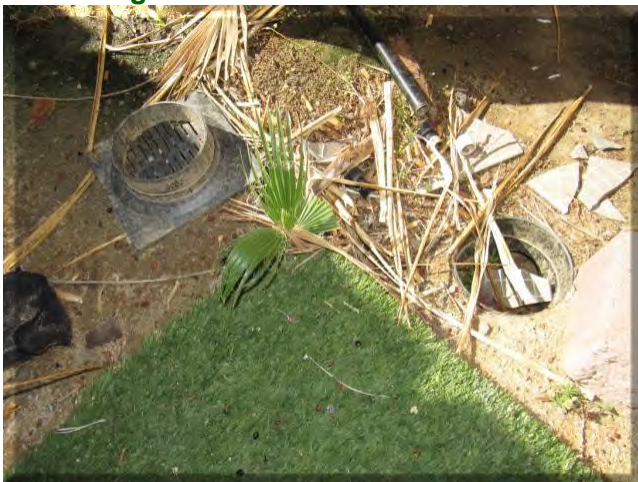
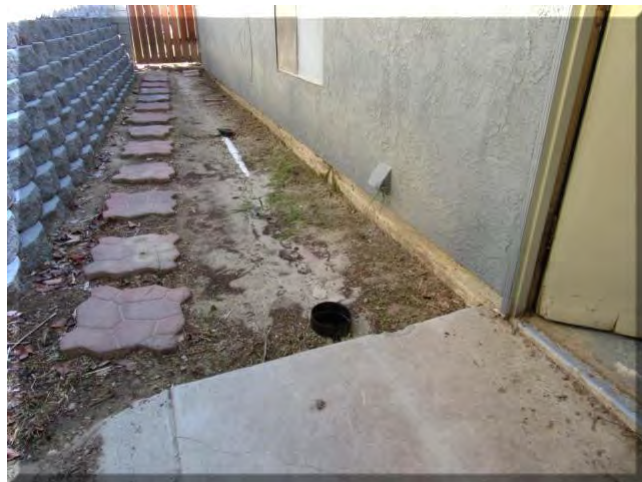
3. Several of the drain covers at the left side of the home are missing. The drains are clogged with debris. The drain near the front right corner of the home is also clogged with debris. Ponding water and excessive moisture conditions may occur at these locations. Although testing of outside area drains is beyond the scope of this inspection, the client is advised to consult a qualified licensed drainage contractor for further evaluation and testing.

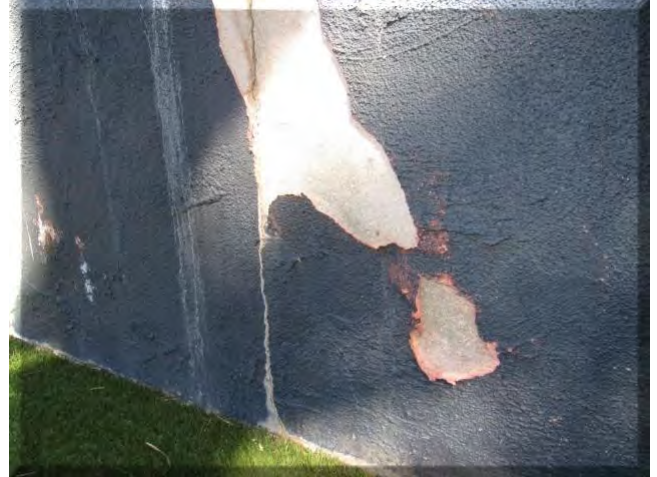
1. Lack of weep holes were noted in the masonry retaining wall at the left side of the lot. Substandard installation. Moisture penetration may occur causing shortened life-span of the wall. The stucco cladding is loose and peeling in several areas where moisture penetration has occurred.

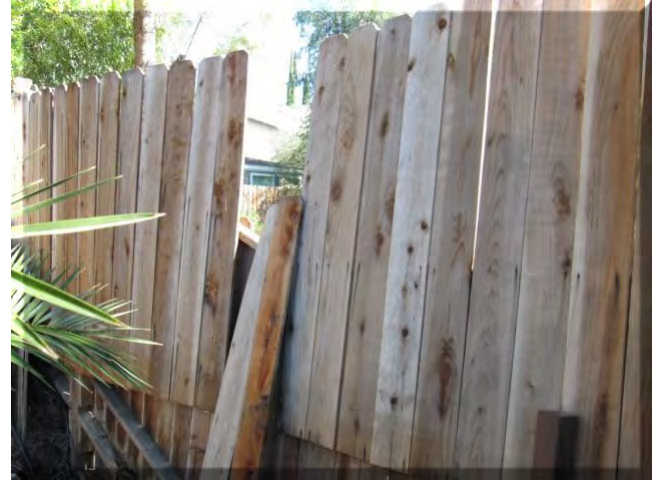
**1. The fence at the rear of the lot is leaning and has several missing boards.**

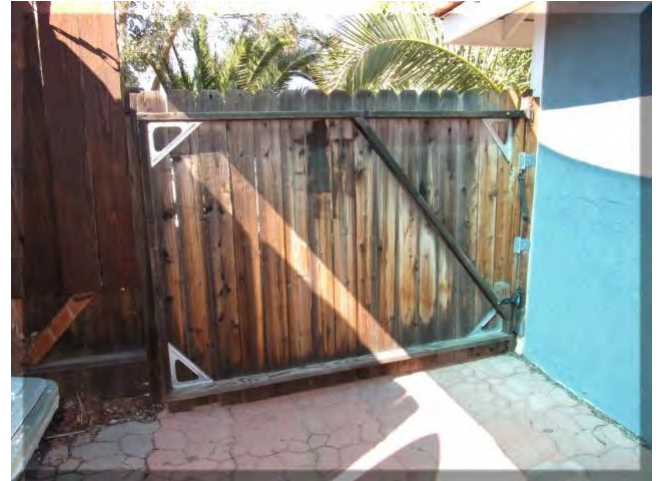
**2. The gates at each side of the home have loose, missing or damaged components and do not function properly.**

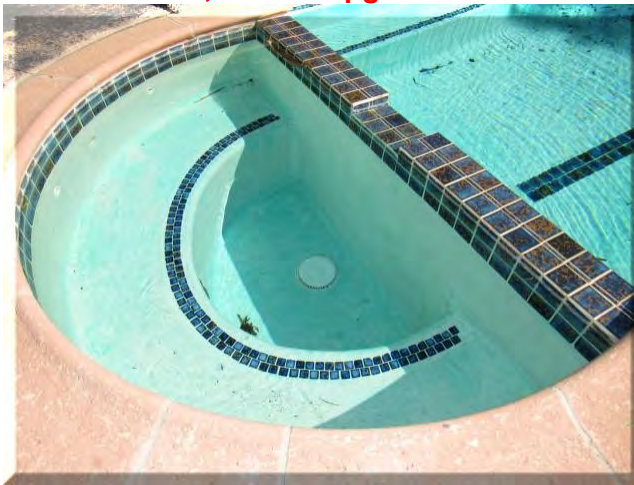
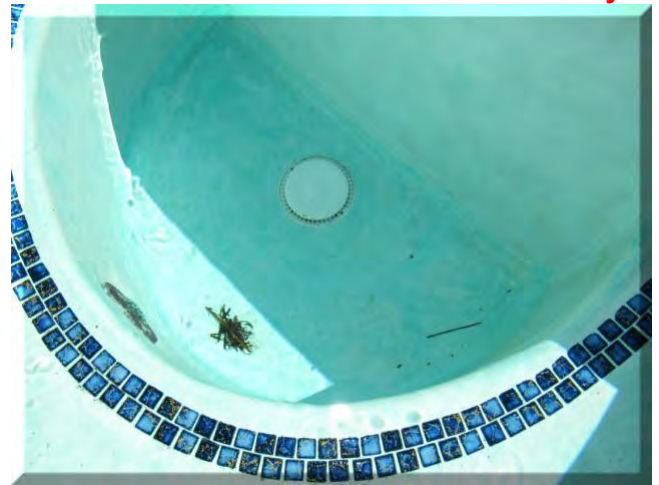
1. There is a single drain in the spa. Entrapment hazard. Although not currently required for residences, a drain upgrade to meet the VGB Act of 2007 is advised for swimmer safety.

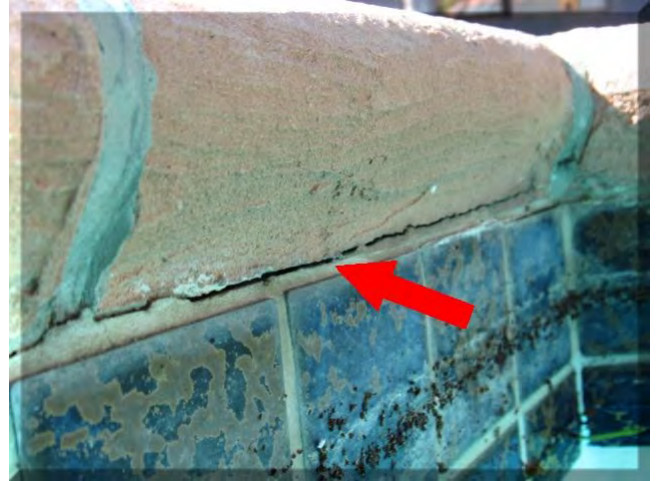
3. The grout line between the pool tile and coping is cracked near the skimmer. Water leakage will occur.

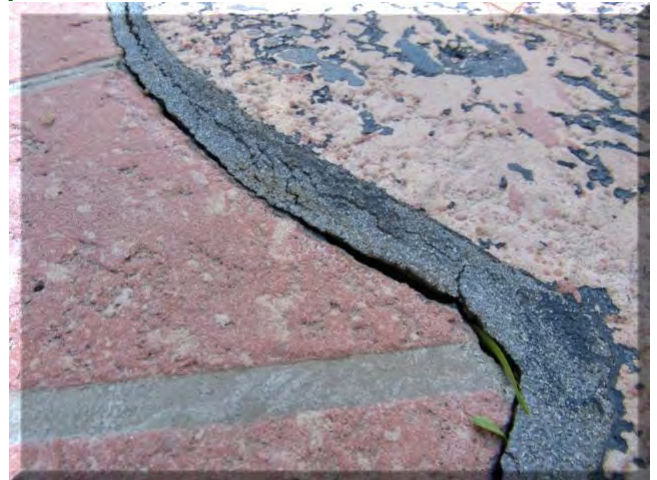
4. The mastic sealant between the deck and coping is deteriorated/cracked. Water entry will occur causing settlement or heaving of the pool deck.

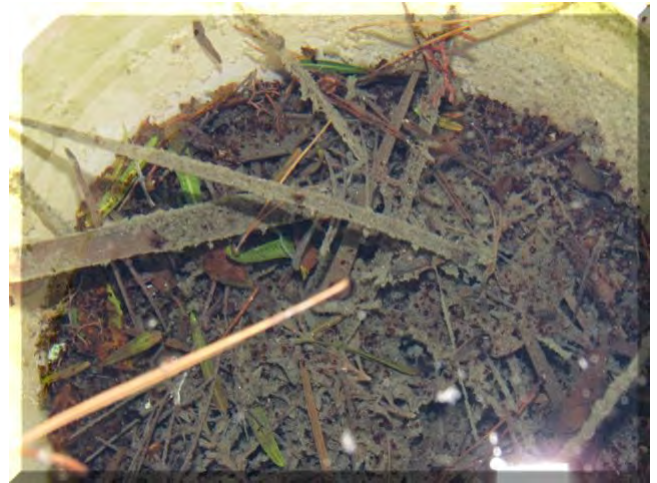
5. The pool skimmers and cleaner are clogged with debris. The cleaner is inoperative. The circulation/filtration system is inoperative as a result. Repairs by a qualified licensed pool contractor are recommended.

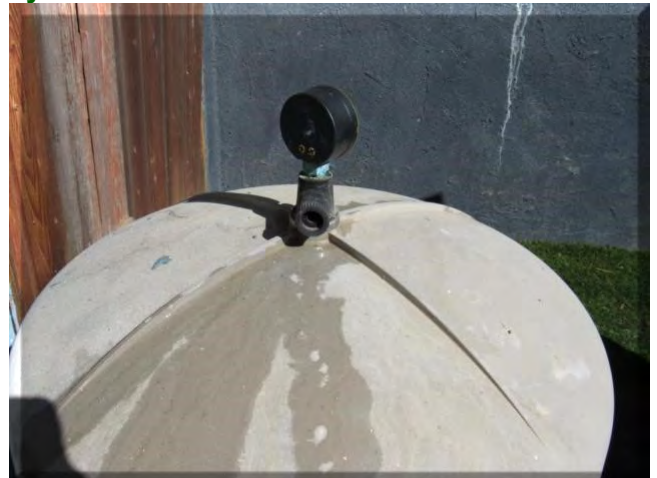
6. The pool filter is leaking at the pressure gauge and band clamp. Air will enter the circulation system causing reduced efficiency.

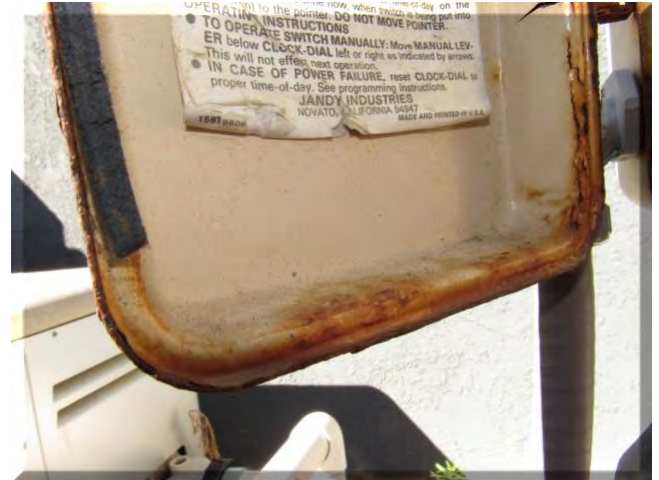
- 8. The pool equipment timer was inoperative when tested. The gasket on the timer box door is deteriorated. Water entry will occur.**

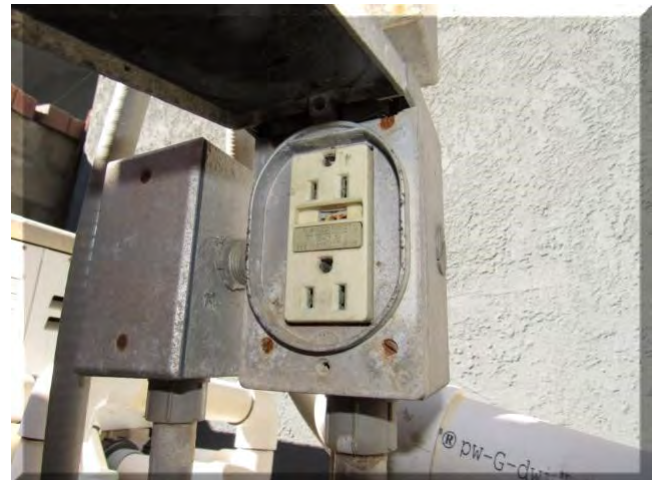
- 9. The GFCI receptacle that protects the pool/spa lights was inoperative when tested. Shock hazard. Replacement is recommended.**

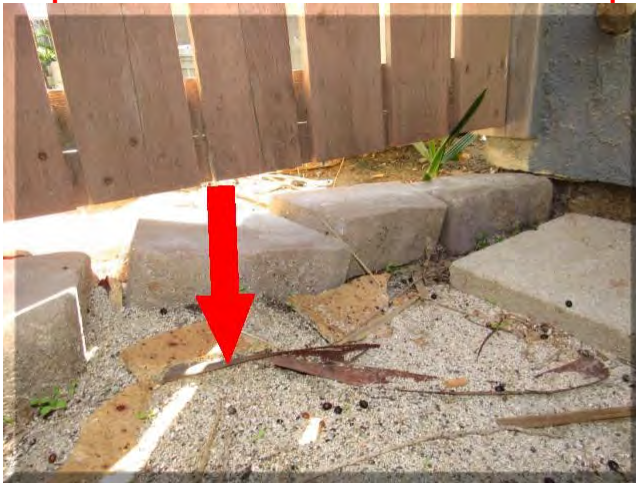
**13. The opening under the pool-accessible gate is excessive. The maximum opening permitted is 2" to soil and 4" to hardscaping. Safety/drowning hazard.**

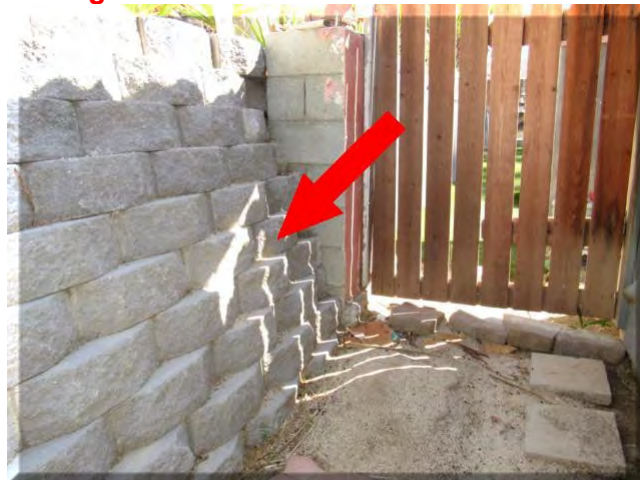
**14. There is a climbable retaining wall adjacent to the exterior of the pool-accessible gate. The pool safety barrier can be breached. Drowning hazard. Correction is advised.**

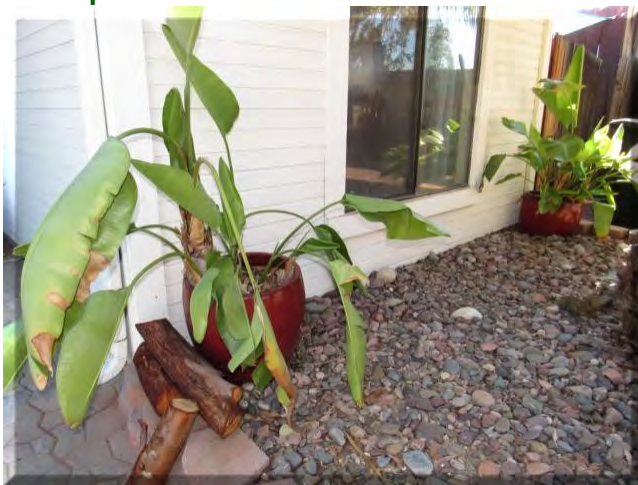
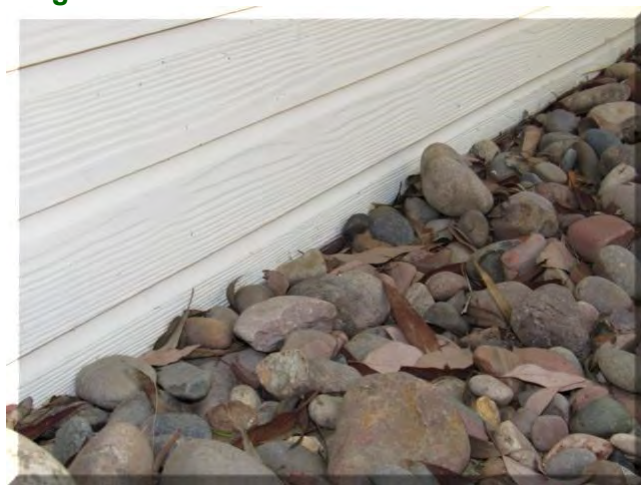
1. The wood siding has inadequate clearance from the soil at the front of the home. It requires 4" clearance from soil. Moisture damage will occur.

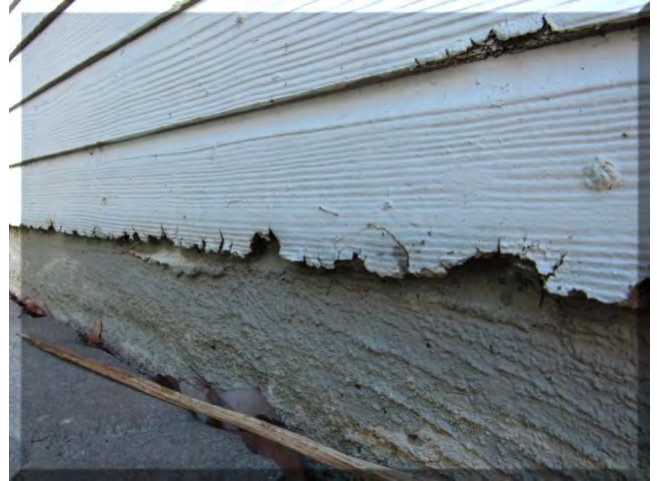
2. Moisture damage was noted in the wood siding at the front entry from splashing water. Refer to the pest control report.

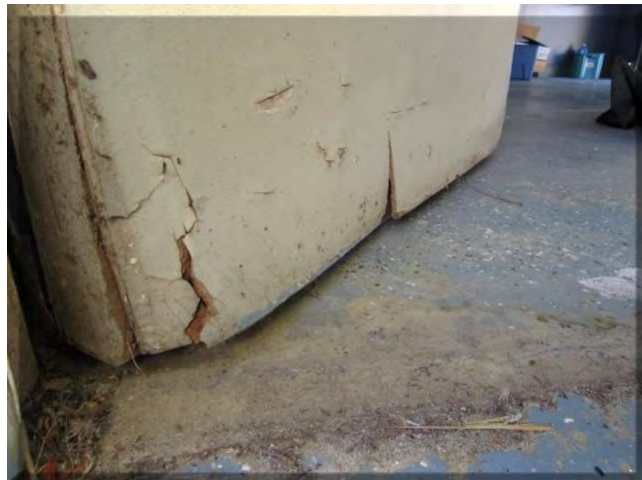
2. Moisture damage was noted at the bottom of the garage service door. Refer to the pest control report.

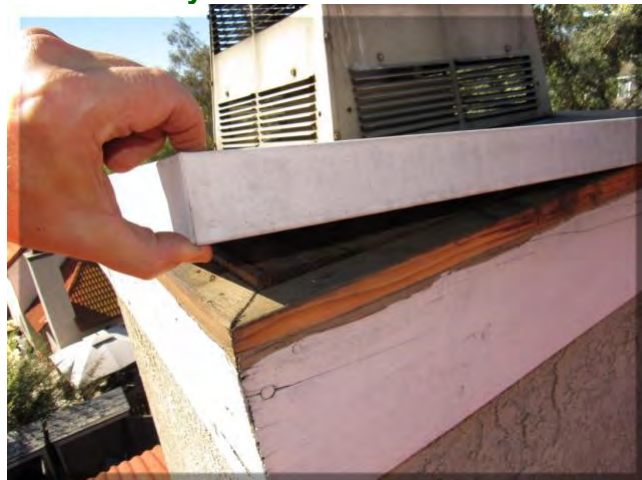
1. The chimney chase cap is loose. Wind lift and water entry will occur.

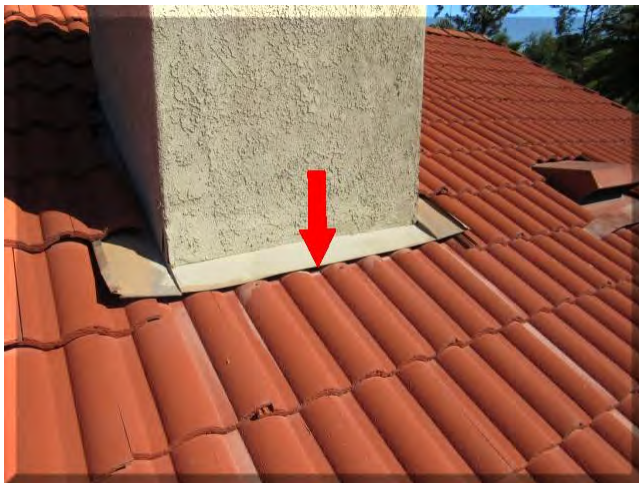
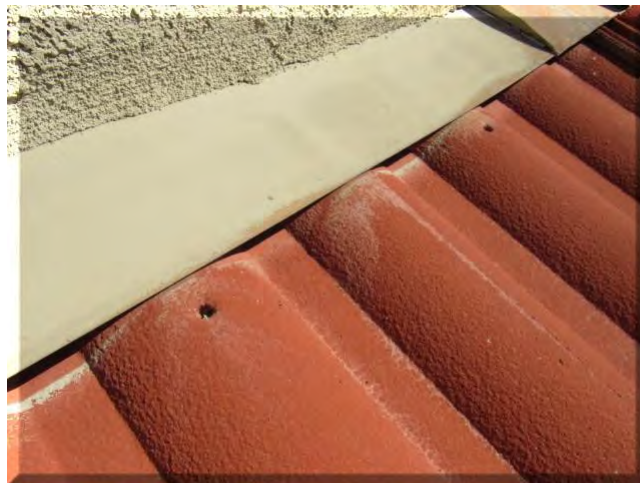
- 1. Inadequate tile head-lap was noted at the head-wall flashing of the chimney and at the roof ridge. Substandard installation. Minimum 3" head-lap is required to prevent water intrusion.**

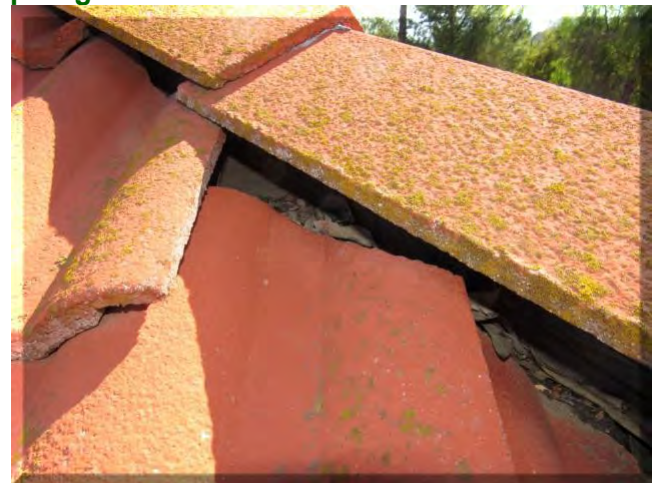
2. Numerous slipped tiles were noted at the hip ridges. Water intrusion will occur.

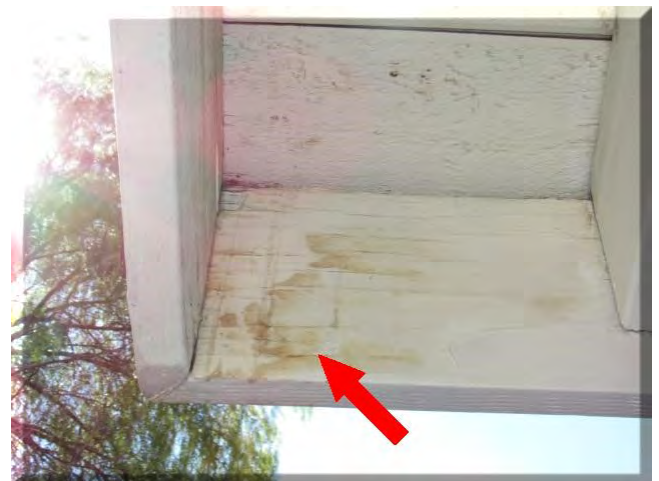
3. Water staining was noted at the roof eaves at the rear right corner of the home. Evidence of roof leakage at the rake edge. Further evaluation is advised.

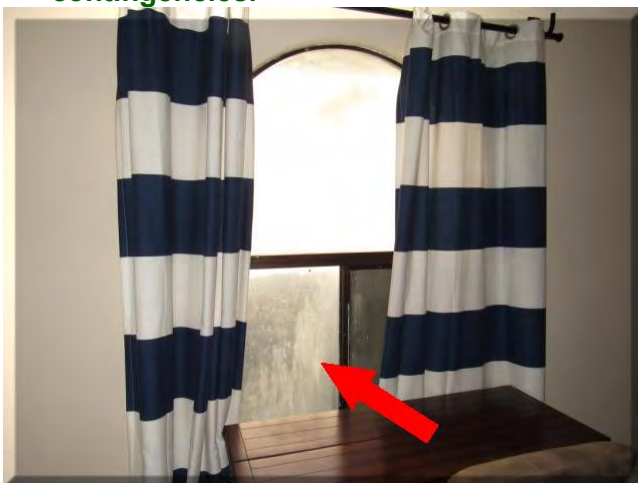
1. There is moisture and/or fogging in the dual-pane window in the guest bedroom. Evidence of hermetic seal failure. Pane replacement is recommended. Due to climatic conditions, the nature of the components, and the cleanliness of the glass, it may not be possible to determine all of the failures present in the home. Evaluation of the remaining windows and doors by a qualified glazier is recommended before the removal of purchase contingencies.

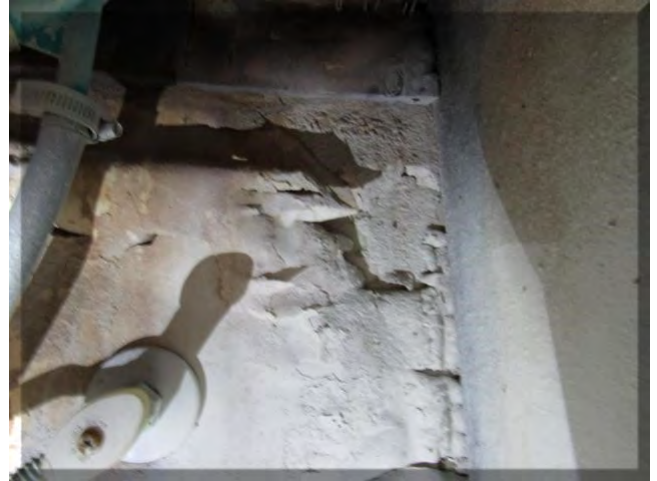
1. **Moisture damage was noted at the wall under the kitchen sink from a previous leak. The sink faucet is leaking. Hidden damage may exist. Further evaluation is recommended.**

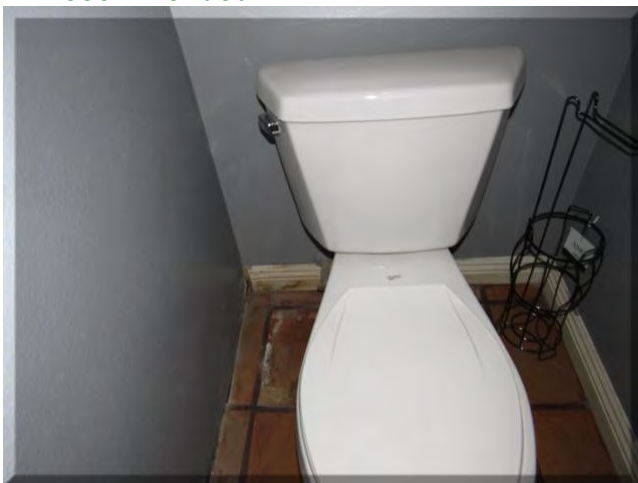
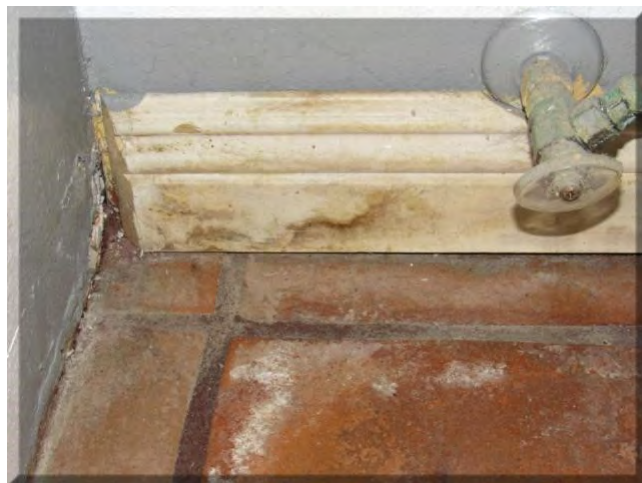
2. Moisture damage was noted at the baseboard moulding behind the toilet from a previous leak. No leaks detected at this time. Further evaluation by a qualified licensed plumber is recommended.

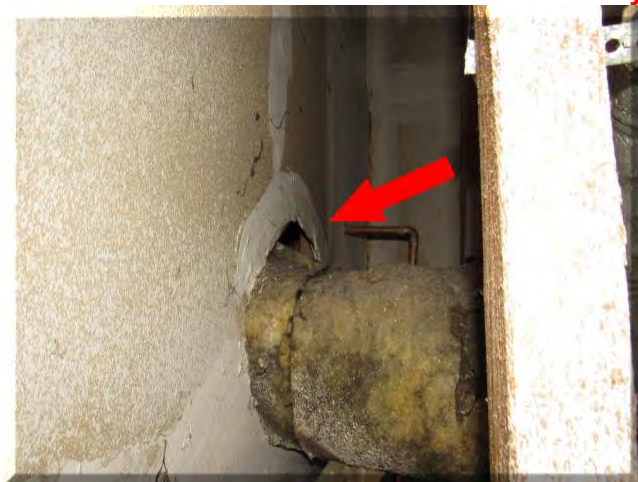
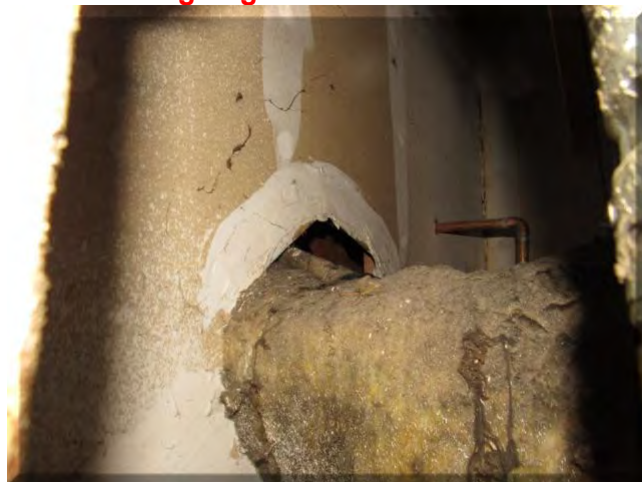
1. There is a hole in the garage wall where the HVAC duct penetrates. This is causing a breach in the fire-resistant-rated assembly between the garage and the home. Fire hazard.

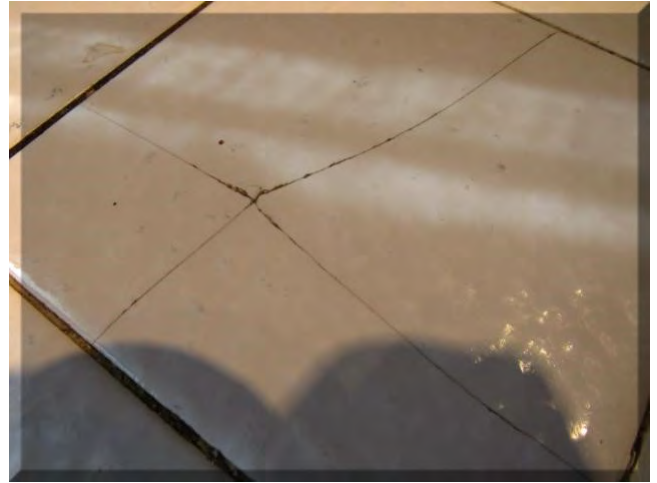
**1. Several of the countertop tiles are cracked. Water penetration will occur.**

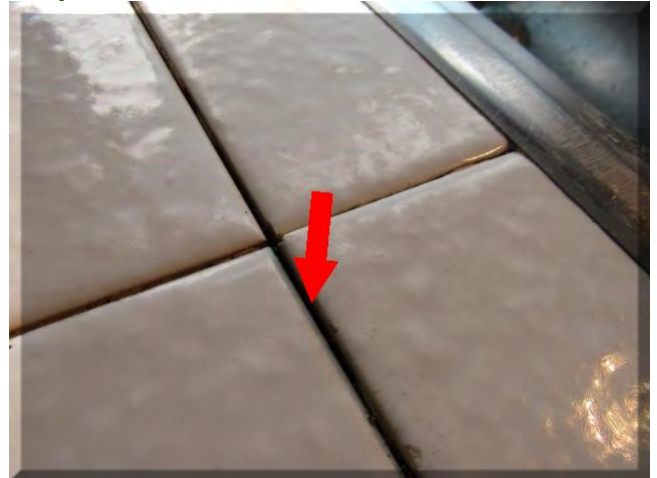
**2. The countertop grouting is deteriorated. Water penetration will occur.**

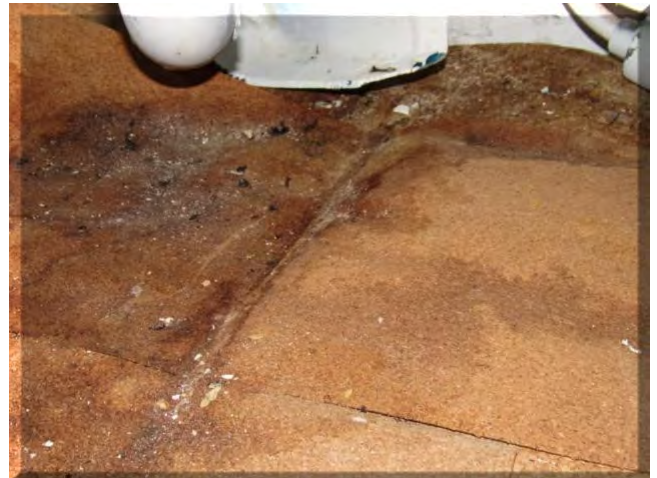
**3. The cabinet floor under the kitchen sink is moisture damaged from a previous leak. The sink faucet is leaking. Hidden damage may exist. Further evaluation is recommended.**

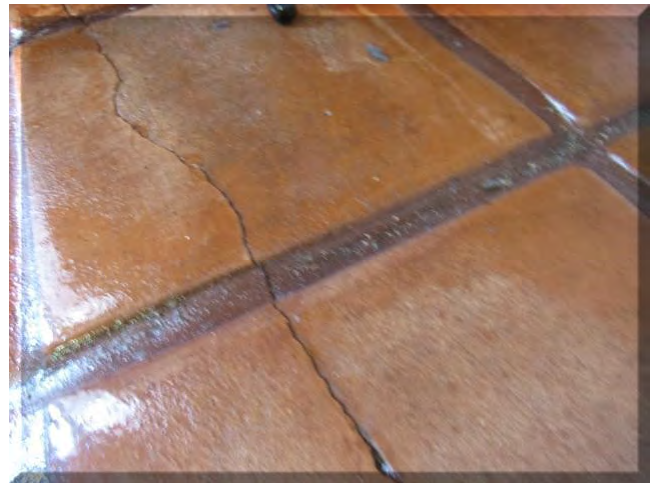
**1. Cracked floor tiles were noted in the dining room adjacent to the refrigerator bay in the kitchen. The floor tiles are stained. Evidence of possible past or present moisture. Further evaluation is recommended.**

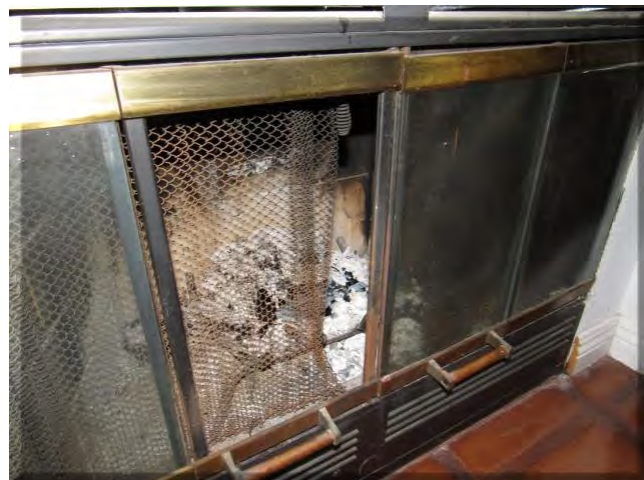
**1. The fireplace door is damaged/missing glass.**

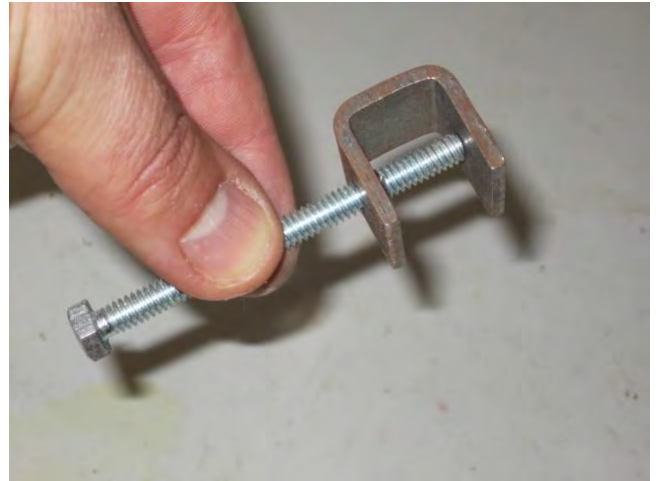
4. To prevent gas leaks from entering the living space, a fireplace damper must be blocked in the full-open position if a gas fixture is present. There is not a damper clamp installed. Safety hazard.

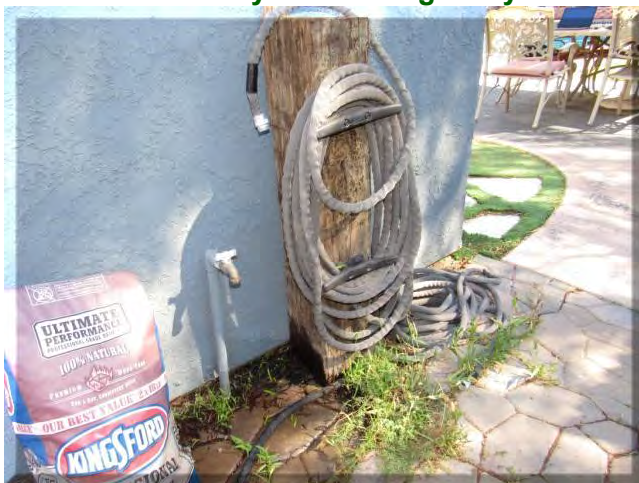
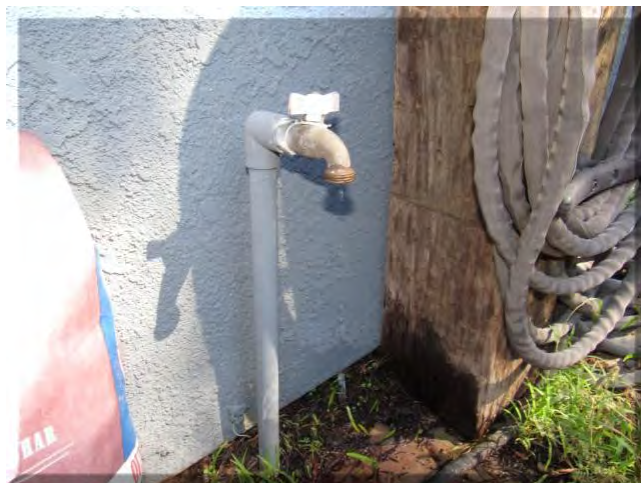
1. The hose bib at the rear right corner of the home is leaking. The PVC pipe is not secured to the wall. Physical damage may occur.

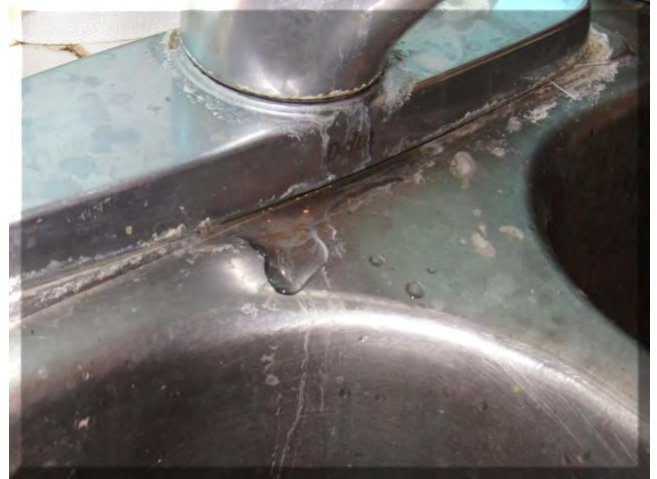
1. The faucet fixture at the kitchen sink is leaking. Moisture damage has occurred at the wall and cabinet floor under the sink.

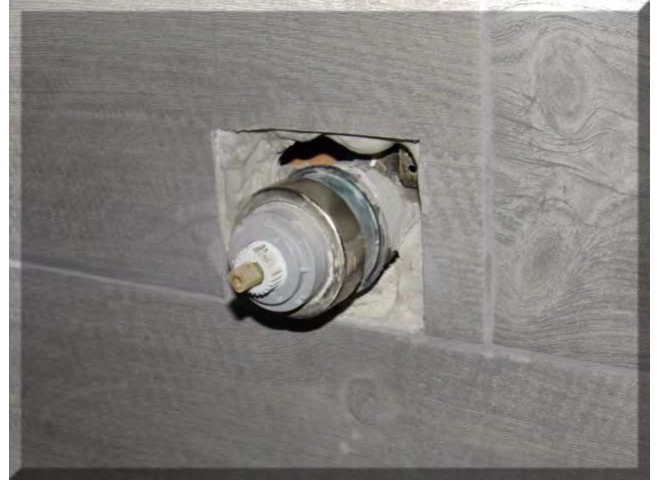
**1. The plumbing fixtures in the shower are incomplete/missing components.**

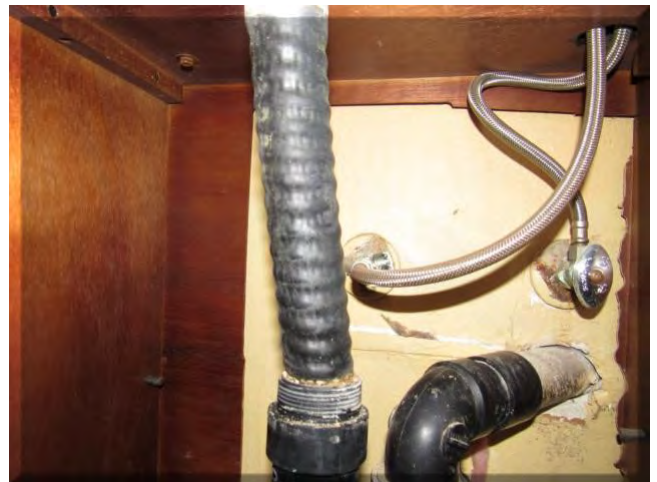
1. Flexible piping and rubber hose are installed at the sink drains. Substandard installation. Clogging and leaks will occur. Replacement with a smooth-surface waste fitting is advised.

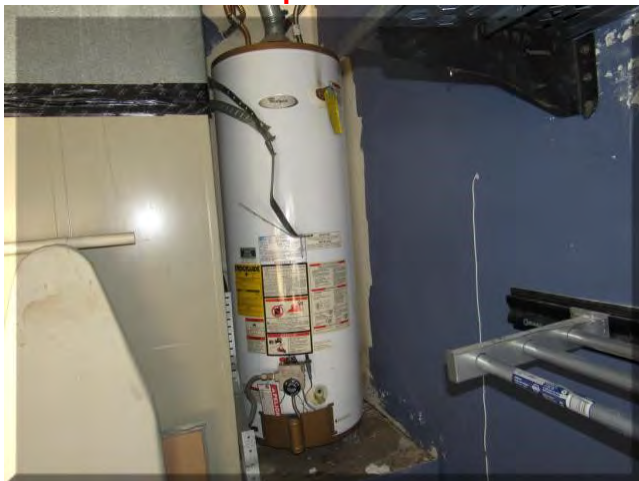
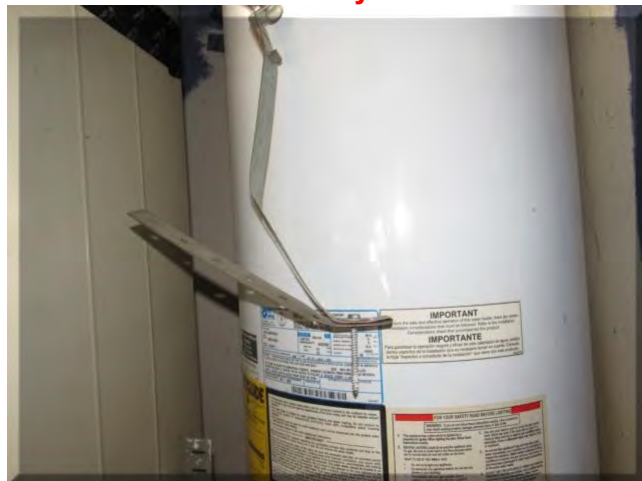
**1. The seismic straps at the water heater are loose/disconnected. Safety hazard.**

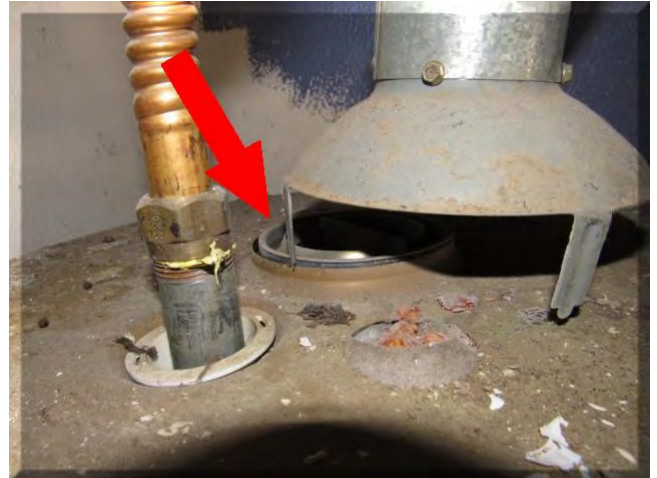
**3. The water heater draft hood is loose/displaced. Carbon monoxide hazard.**

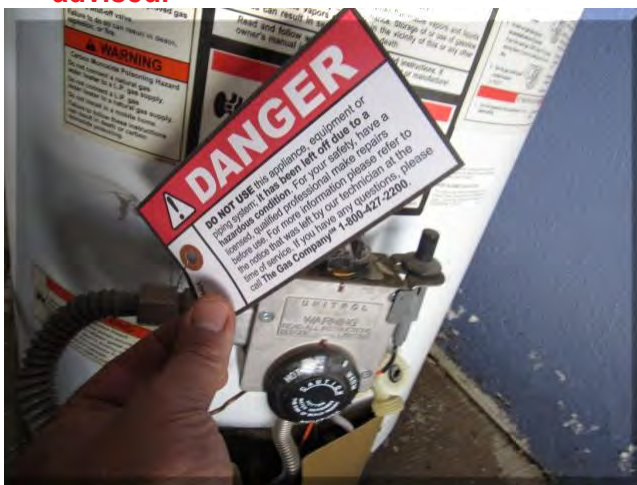
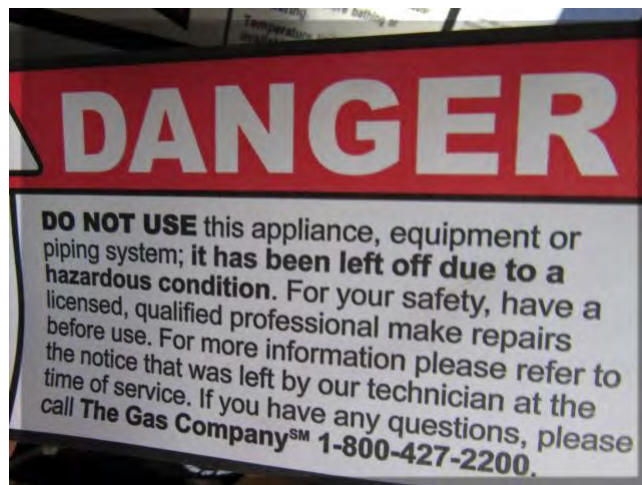
4. The water heater has been red-tagged by the gas utility for a "hazardous condition". It is unknown what the hazardous condition is or if it has been corrected. Further evaluation is advised.

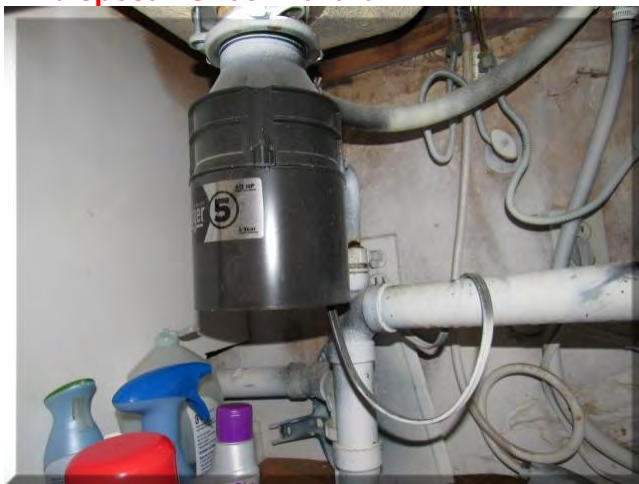
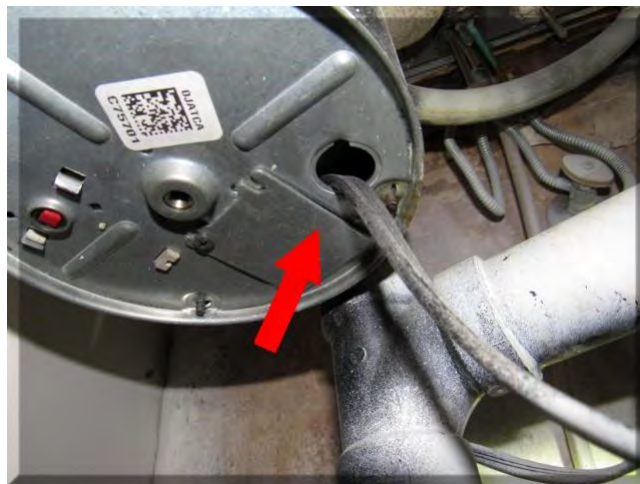
1. **There is not a strain-relief clamp installed where the appliance cord enters the food waste disposal. Shock hazard.**

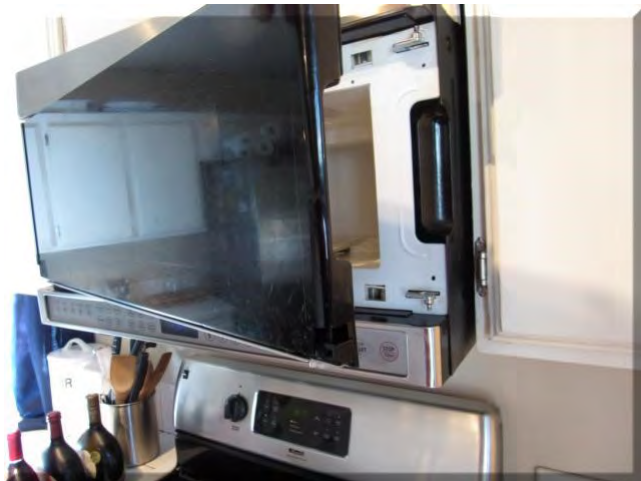
1. The microwave oven door and latch are damaged and do not function properly.

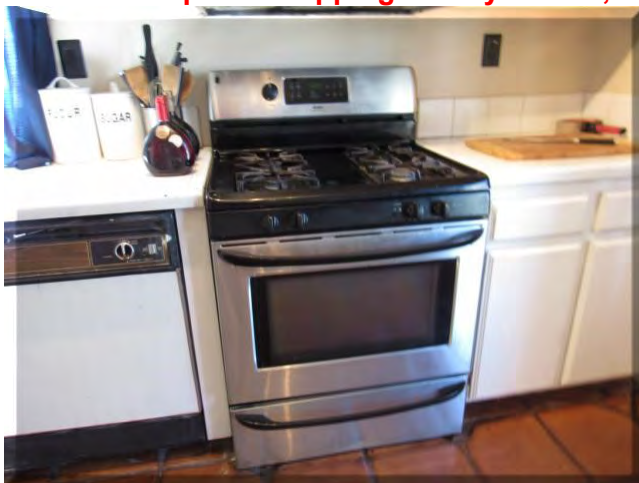
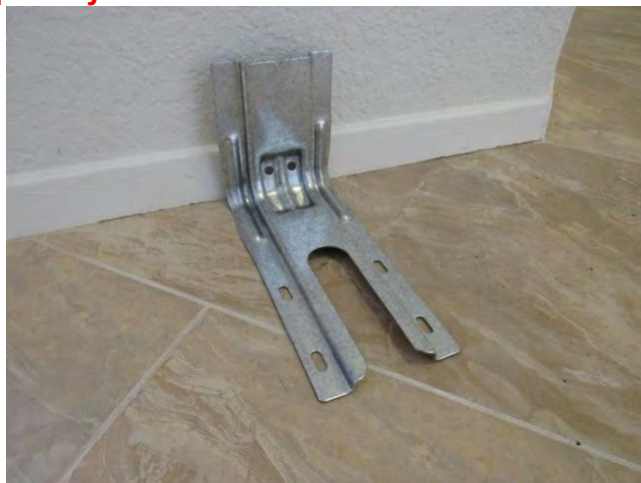
1. The anti-tip bracket for the free-standing range is missing or is improperly positioned and does not prevent tipping. Safety hazard, especially for small children.

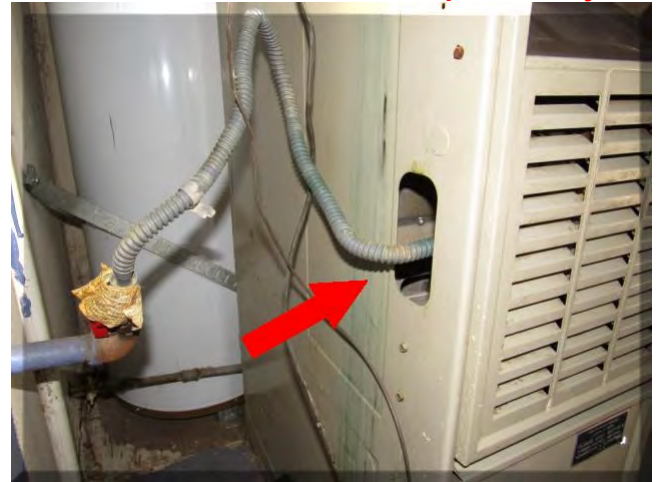
1. **A flexible gas connector penetrates the furnace cabinet. Fire hazard. Current industry standards require hard-piping through the cabinet with the flex connector attachment at the exterior of the unit. Upgrading to current standards is advised for occupant safety.**

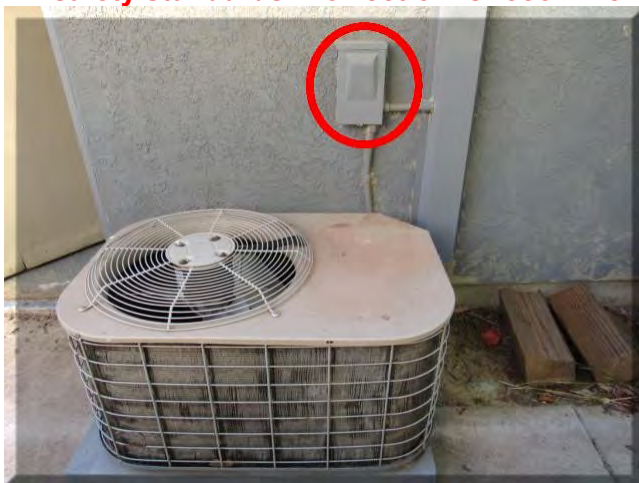
1. **The electrical disconnect for the A/C condenser is improperly located behind the unit. There is inadequate clearance in front of the disconnect box. A 30" wide X 36" deep working space is required in front of electrical disconnects. Does not meet electrical safety standards. Correction is recommended.**

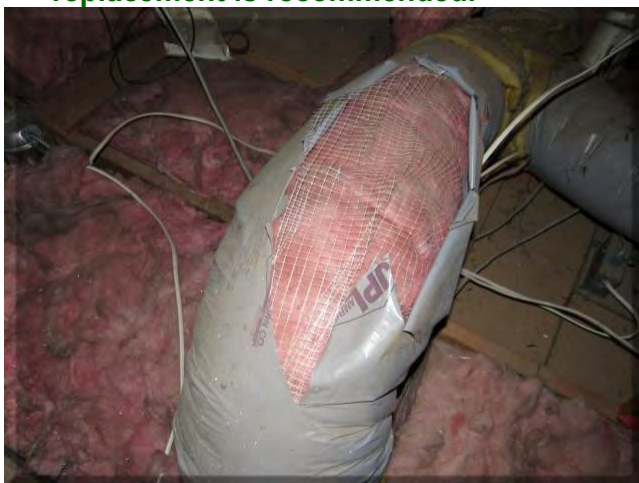
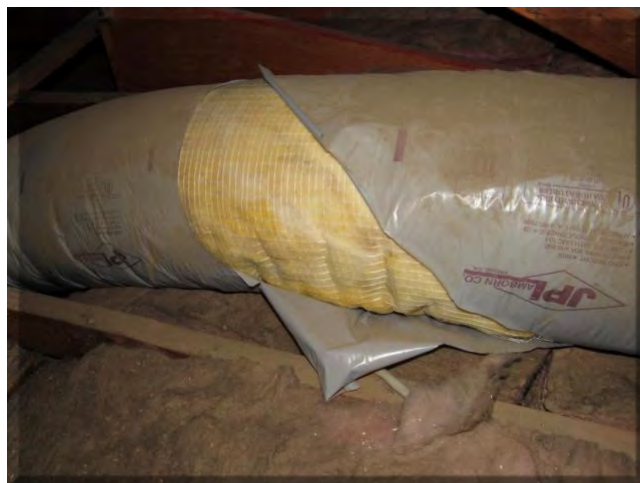
1. **Some of the HVAC ducts in the attic are deteriorated. The vapor barrier is peeling. The insulation jacket will loosen and open. Reduced system efficiency will occur. Duct replacement is recommended.**

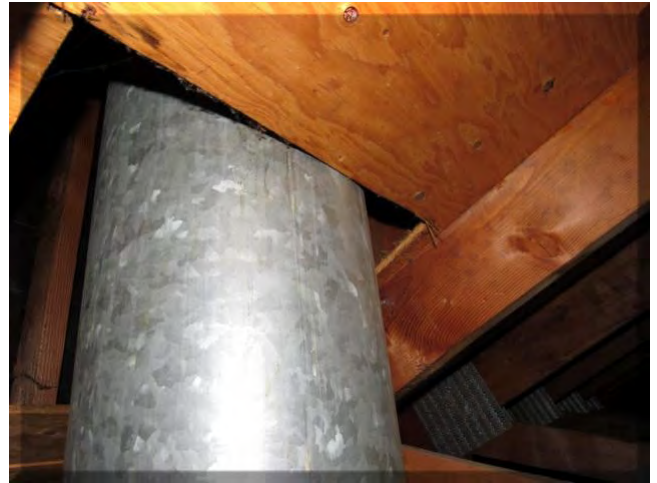
2. The fireplace flue is in contact with the plywood where it passes through the roof. (Minimum 1" clearance required.) Fire hazard.

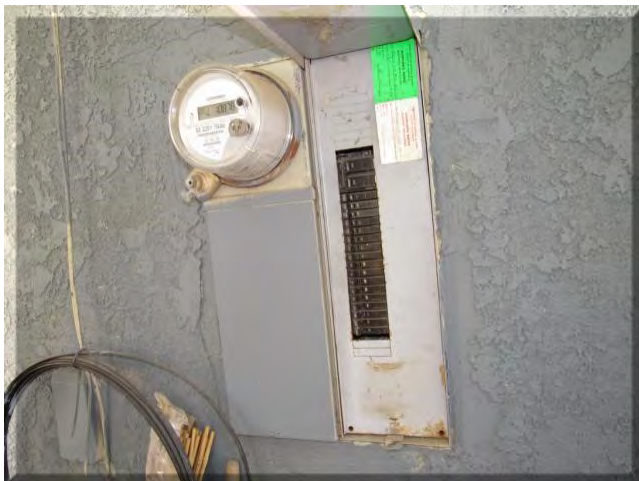
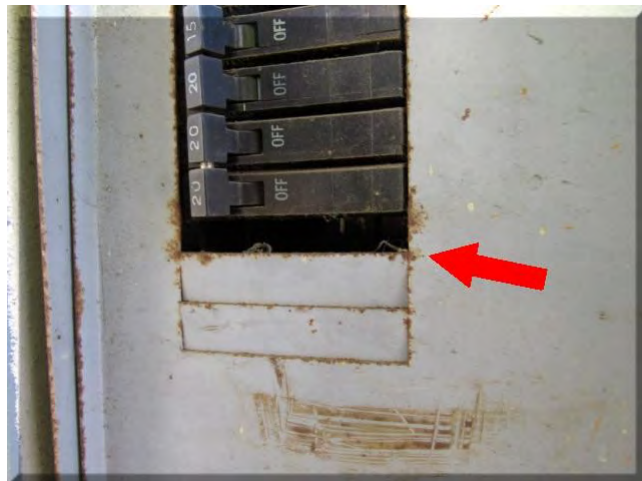
1. **Missing breaker tabs were noted in the dead-front cover of the electrical service panel. Shock hazard.**

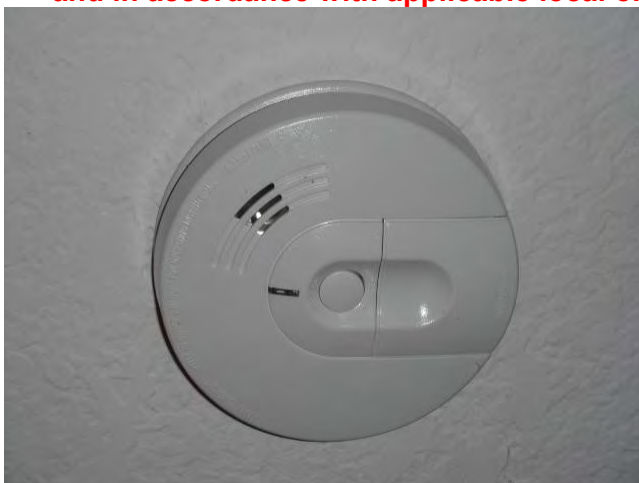
1. **There are no smoke alarms installed in the home. Fire/safety hazard to the occupants. Smoke alarms must be installed in accordance with the State Fire Marshall's regulations and in accordance with applicable local ordinances.**

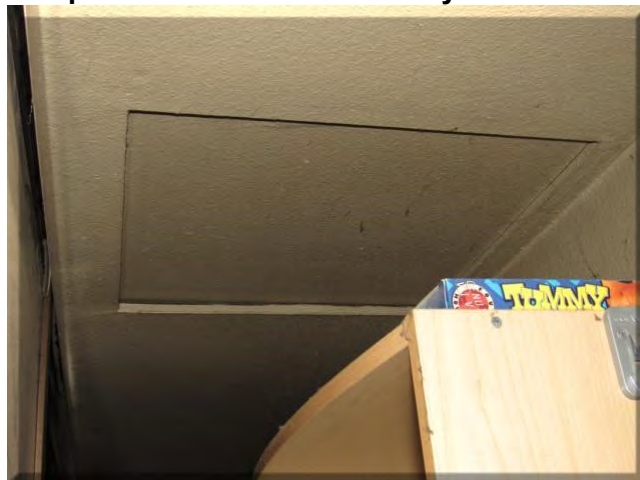
**The attic space at the right side of the home (in the master bedroom closet) was not readily accessible. The master bedroom closet doors have damaged rollers and could not be opened to enter the attic access. This attic area was not inspected. Hidden defects may exist.**

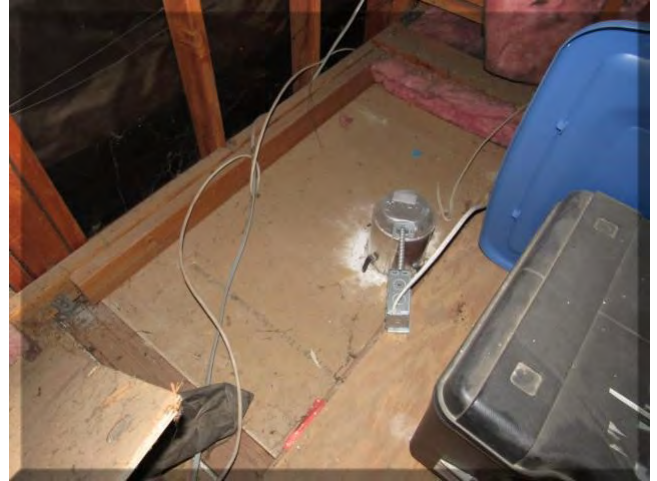
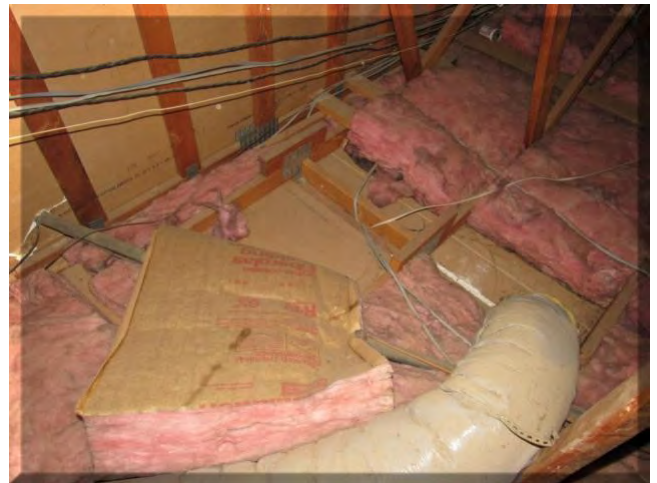
1. Several displaced or missing batts of insulation were noted in the attic. Reduced energy efficiency will occur. Replacement is advised.

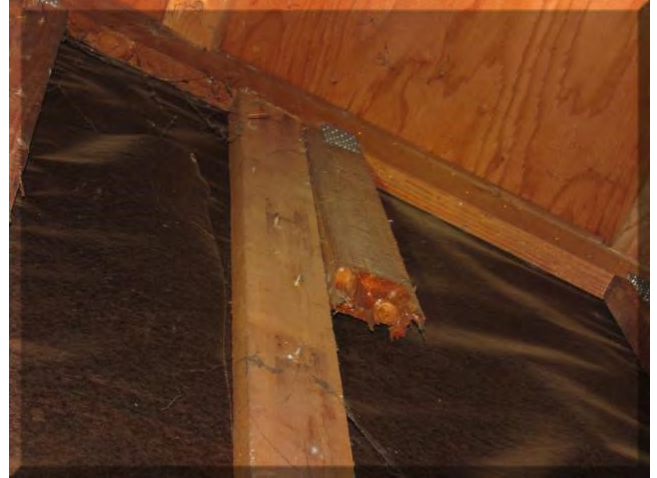
2. There are a couple of damaged roof truss webs at the front gable wall in the garage attic. Field repairs were noted. Roof trusses are engineered structural components and any repairs to them must be engineer approved. The structural integrity of the roof may be compromised. Evaluation and recommendation for repairs by a qualified structural framing engineer are advised.
